Quality Assurance and Source Inspection

Contract #: 04-0120F4Cty: SF/ALA Rte: 80 PM: 13.2/13.9File #: 69.28**WELDING INSPECTION REPORT****Resident Engineer:** Siegenthaler, Peter**Address:** 333 Burma Road**City:** Oakland, CA 94607**Report No:** WIR-018965**Date Inspected:** 17-Dec-2010**Project Name:** SAS Superstructure**OSM Arrival Time:** 700**Prime Contractor:** American Bridge/Fluor Enterprises, a JV**OSM Departure Time:** 1900**Contractor:** Zhenhua Port Machinery Company, Ltd (ZPMC), Changxing Island **Location:** Shanghai, China

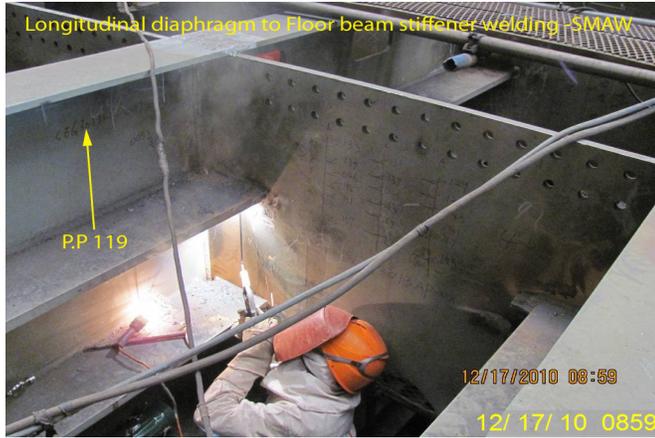
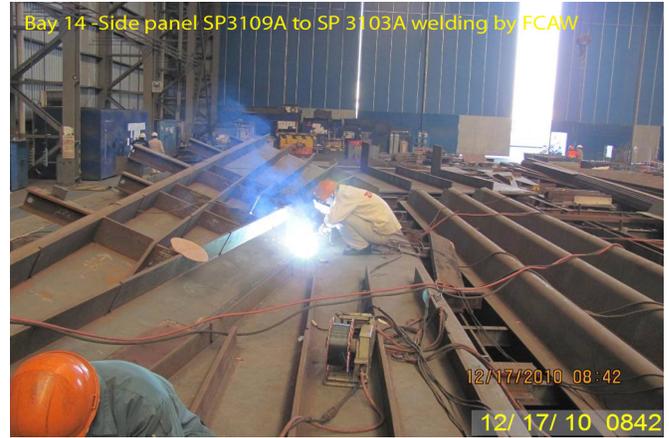
For further information see below pictures:-

Unless otherwise noted, all work observed on this date appeared to be in general compliance with the applicable contract documents.
