Quality Assurance and Source Inspection

Contract #: 04-0120F4Cty: SF/ALA Rte: 80 PM: 13.2/13.9File #: 82.28**WELDING INSPECTION REPORT****Resident Engineer:** Siegenthaler, Peter**Address:** 333 Burma Road**City:** Oakland, CA 94607**Report No:** WIR-019045**Date Inspected:** 21-Dec-2010**Project Name:** SAS Superstructure**OSM Arrival Time:** 500**Prime Contractor:** American Bridge/Fluor Enterprises, a JV**OSM Departure Time:** 1530**Contractor:** Westmont Industries**Location:** Santa Fe Springs, CA.**CWI Name:** Ruben Dominguez**CWI Present:** Yes No**Inspected CWI report:** Yes No N/A**Rod Oven in Use:** Yes No N/A**Electrode to specification:** Yes No N/A**Weld Procedures Followed:** Yes No N/A**Qualified Welders:** Yes No N/A**Verified Joint Fit-up:** Yes No N/A**Approved Drawings:** Yes No N/A**Approved WPS:** Yes No N/A**Delayed / Cancelled:** Yes No N/A**Bridge No:** 34-0006**Component:** Travelers**Summary of Items Observed:**

SAS-EB Traveler**Fixed Stairs Section**

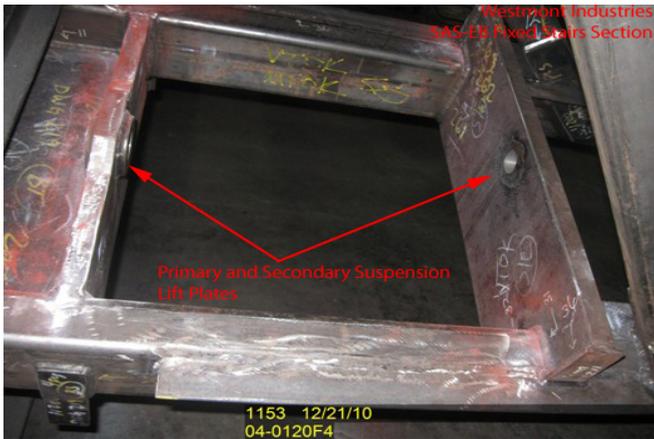
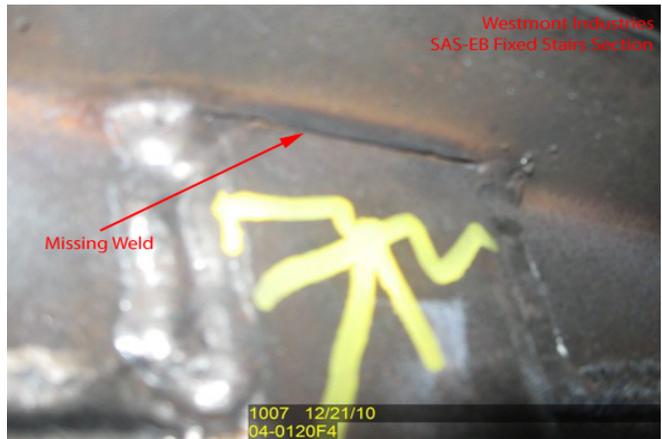
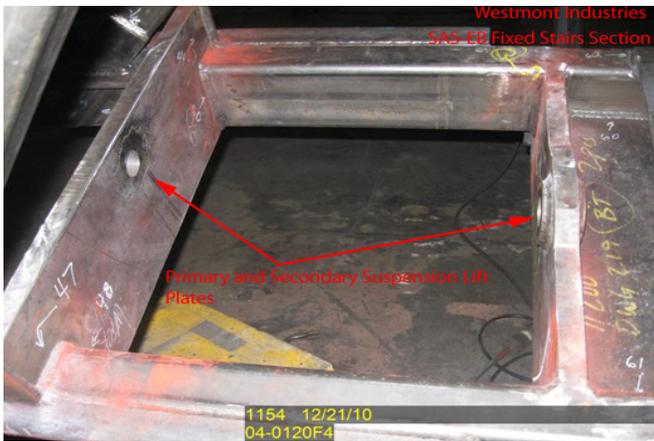
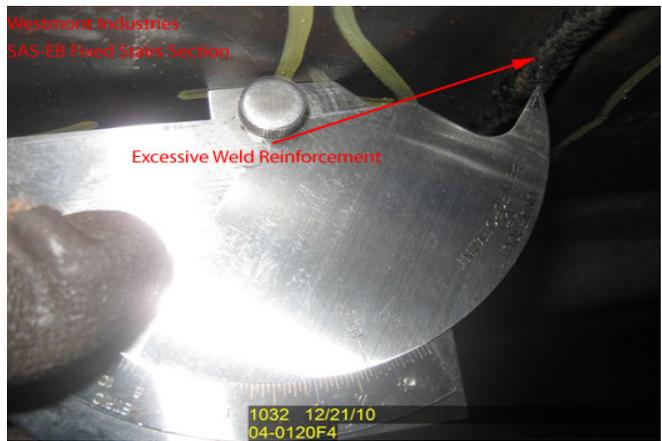
On this date, the QA Inspector performed random Visual Testing (VT) on the previously completed fillet and flare groove welds, for the Fixed Stairs Section. The QA Inspector noted that SE QC Inspector Mr. Ruben Dominguez had previously performed VT and had accepted the welds. During testing, the QA Inspector observed that some of the welds appeared to be non-conforming to the requirements of AWS D1.1 2002, Visual Testing and the contract Special Provisions. The QA Inspector observed areas of excessive weld undercut, reinforcement and a missing 3 mm seal weld. Additionally, the QA Inspector observed that excessive weld spatter was present on random areas, nearby the weld reinforcement. The QA Inspector also observed numerous flame cut and plate edges, were present on plate material. The QA Inspector noted that per SSPC-10, that all sharp edges should be smoothed, prior to primer and or paint application. The QA Inspector then marked these above mentioned areas, utilizing a paint stick marker and then notified Shop Supervisor Juan Mora. Mr. Mora then explained to the QA Inspector that

the areas which were marked by the QA Inspector will be fixed. Additionally, the QA Inspector performed 100% Magnetic Particle Testing (MT) on the previously completed fillet welds, for the primary and secondary suspension lift plates. The QA Inspector noted that SE QC Inspector Mr. Ruben Dominguez had previously performed 100% MT and had found no rejectable indications. After testing, the QA Inspector found no rejectable indications. Later in the shift, the QA Inspector observed production welder Mr. Jose Rodriguez (WID # 3031) utilizing a mechanical grinder and performing FCAW activities, to fix the areas.

See completed TL6028 and attached pictures below, for additional details.
