Contract #: 04-0120F4Cty: SF/ALA Rte: 80 PM: 13.2/13.9File #: 69.28**WELDING INSPECTION REPORT****Resident Engineer:** Siegenthaler, Peter**Address:** 333 Burma Road**City:** Oakland, CA 94607**Report No:** WIR-019061**Date Inspected:** 03-Jan-2011**Project Name:** SAS Superstructure**OSM Arrival Time:** 700**Prime Contractor:** American Bridge/Fluor Enterprises, a JV**OSM Departure Time:** 1900**Contractor:** Zhenhua Port Machinery Company, Ltd (ZPMC), Changxing Island **Location:** Shanghai, China**CWI Name:** Mr. Liu fa wen**CWI Present:** Yes No**Inspected CWI report:** Yes No N/A**Rod Oven in Use:** Yes No N/A**Electrode to specification:** Yes No N/A**Weld Procedures Followed:** Yes No N/A**Qualified Welders:** Yes No N/A**Verified Joint Fit-up:** Yes No N/A**Approved Drawings:** Yes No N/A**Approved WPS:** Yes No N/A**Delayed / Cancelled:** Yes No N/A**Bridge No:** 34-0006**Component:** Orthotropic Box Girder (OBG)**Summary of Items Observed:**

WELDING INSPECTION REPORT

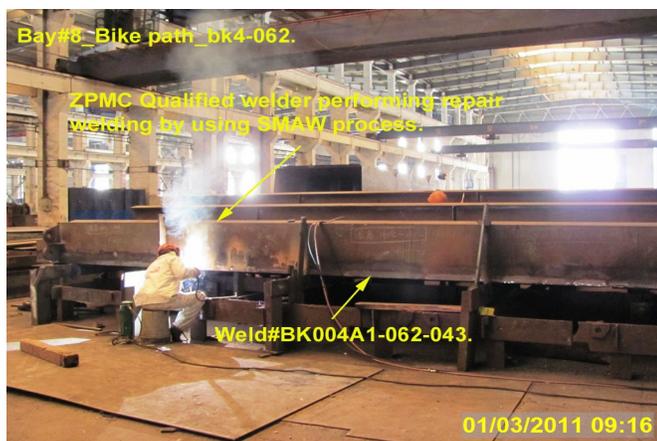
Shielded Metal Arc Welding (SMAW) Repair welding of weld joint identified as BK004A1-062-043. Welders are identified as 069894. ZPMC Quality Control (QC) is identified as Mr. Liu chuan gang. The welding variables appeared to comply with the Applicable WPS: WPS-345-SMAW-2G (2F)-Repair. The repair welding was being performed as per the Caltrans approved Critical Welding Repair Report (CWR) No: B-CWR2481. This weld was rejected by ZPMC QC personnel and recorded on UT report B787-UT-17775. Refer the attached photos for reference.
