Contract #: 04-0120F4Cty: SF/ALA Rte: 80 PM: 13.2/13.9File #: 69.28**WELDING INSPECTION REPORT****Resident Engineer:** Siegenthaler, Peter**Address:** 333 Burma Road**City:** Oakland, CA 94607**Report No:** WIR-019105**Date Inspected:** 20-Dec-2010**Project Name:** SAS Superstructure**OSM Arrival Time:** 700**Prime Contractor:** American Bridge/Fluor Enterprises, a JV**OSM Departure Time:** 1900**Contractor:** Zhenhua Port Machinery Company, Ltd (ZPMC), Changxing Island **Location:** Shanghai, China**CWI Name:** Lv Li Qing**CWI Present:** Yes No**Inspected CWI report:** Yes No N/A**Rod Oven in Use:** Yes No N/A**Electrode to specification:** Yes No N/A**Weld Procedures Followed:** Yes No N/A**Qualified Welders:** Yes No N/A**Verified Joint Fit-up:** Yes No N/A**Approved Drawings:** Yes No N/A**Approved WPS:** Yes No N/A**Delayed / Cancelled:** Yes No N/A**Bridge No:** 34-0006**Component:** OBG**Summary of Items Observed:**

WELDING INSPECTION REPORT

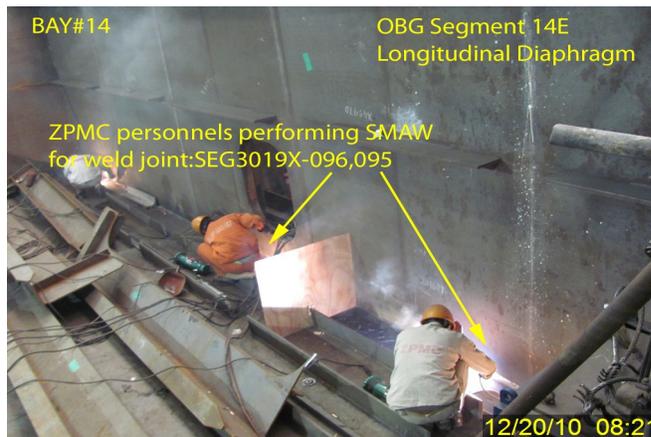
SMAW in the 2G position for the OBG Segment 14E Longitudinal Diaphragm to Bottom panel. The weld joint was designated as: SEG3019X-96. The welder is identified as #067611. ZPMC QC is identified as Mr. Zhong Guo Hui.. The welding variables recorded by QC appear to comply with WPS-B-P-2212-TC-U4B. Please see the attached picture
