DEPARTMENT OF TRANSPORTATION

Quality Assurance and Source Inspection

Contract #: 04-0120F4Cty: SF/Ala Rte: 80 PM: 13.2/13.9File #: 69.28**WELDING INSPECTION REPORT****Resident Engineer:** Siegenthaler, Peter**Address:** 333 Burma Road**City:** Oakland, CA 94607**Report No:** WIR-019179**Date Inspected:** 29-Dec-2010**Project Name:** SAS Superstructure**OSM Arrival Time:** 1900**Prime Contractor:** American Bridge/Fluor Enterprises, a JV**OSM Departure Time:** 700**Contractor:** Zhenhua Port Machinery Company, Ltd (ZPMC), Changxing Island **Location:** Shanghai, China**CWI Name:** See below**CWI Present:** Yes No**Inspected CWI report:** Yes No N/A**Rod Oven in Use:** Yes No N/A**Electrode to specification:** Yes No N/A**Weld Procedures Followed:** Yes No N/A**Qualified Welders:** Yes No N/A**Verified Joint Fit-up:** Yes No N/A**Approved Drawings:** Yes No N/A**Approved WPS:** Yes No N/A**Delayed / Cancelled:** Yes No N/A**Bridge No:** 34-0006**Component:** OBG and Tower Components**Summary of Items Observed:**

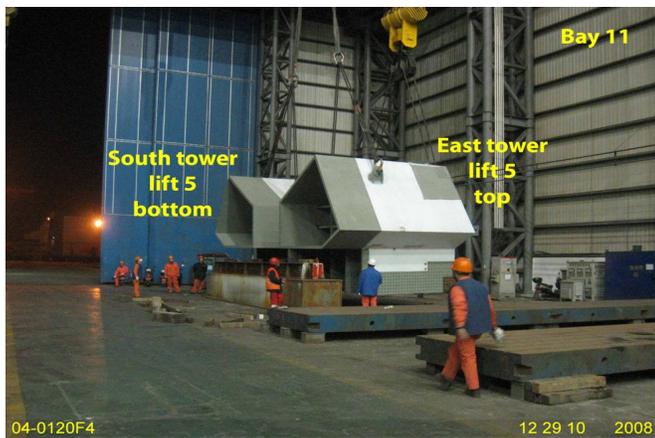
ZPMC workers moved the attached north and west towers, lift 5, positioned horizontally onto the ends of skin A connection plates on dunnage on the shop floor using the overhead crane. See photo below of the attached shaft sections being lowered into place.
