Contract #: 04-0120F4Cty: SF/ALA Rte: 80 PM: 13.2/13.9File #: 99.28**WELDING INSPECTION REPORT****Resident Engineer:** Siegenthaler, Peter**Address:** 333 Burma Road**City:** Oakland, CA 94607**Report No:** WIR-019190**Date Inspected:** 09-Jan-2011**Project Name:** SAS Superstructure**OSM Arrival Time:** 700**Prime Contractor:** American Bridge/Fluor Enterprises, a JV**OSM Departure Time:** 1900**Contractor:** Zhenhua Port Machinery Company, Ltd (ZPMC)**Location:** Shanghai, China**CWI Name:** Li Yang and Zhu Zhong Hai**CWI Present:** Yes No**Inspected CWI report:** Yes No N/A**Rod Oven in Use:** Yes No N/A**Electrode to specification:** Yes No N/A**Weld Procedures Followed:** Yes No N/A**Qualified Welders:** Yes No N/A**Verified Joint Fit-up:** Yes No N/A**Approved Drawings:** Yes No N/A**Approved WPS:** Yes No N/A**Delayed / Cancelled:** Yes No N/A**Bridge No:** 34-0006**Component:** OBG Trial Assembly**Summary of Items Observed:**

Orthotropic Box Girder (OBG) at Trial Assembly Areas

WELDING INSPECTION REPORT

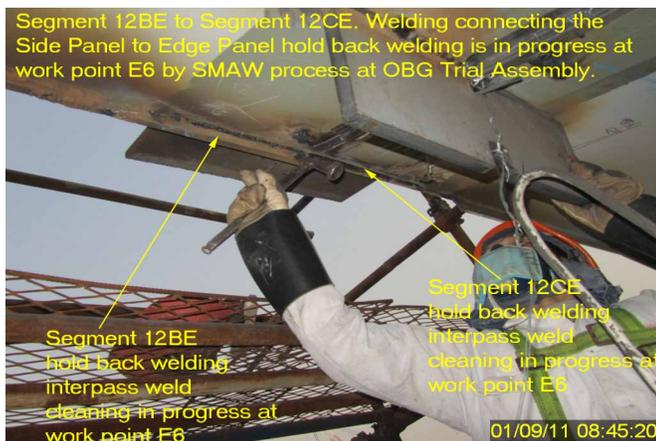
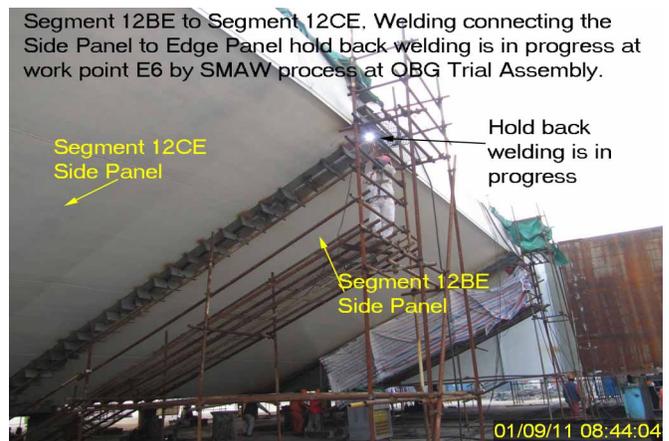
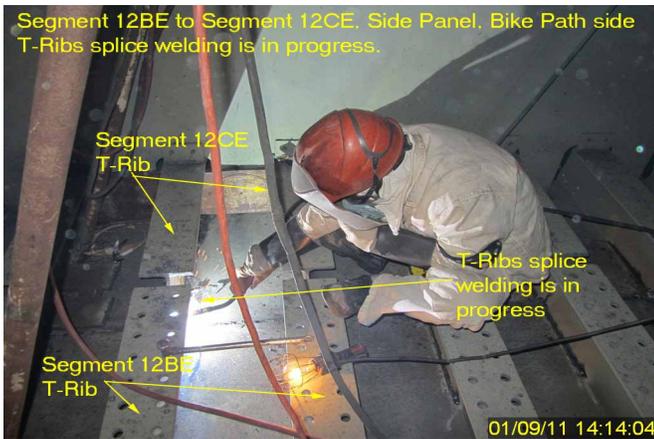
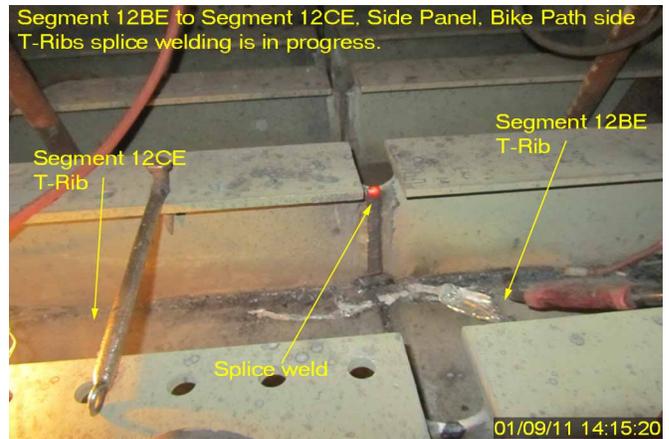
This QA Inspector observed the in-process welding by Shielded Metal Arc Welding (SMAW) process on a Complete Joint Penetration (CJP) groove weld. The Weld joint was designated as CA3002-005. The welder identification was 050789 and was observed welding in the 4G (Overhead) position using approved Welding Procedure Specification WPS-B-P-2214-Tc-U4b-FCM-1. The piece mark was identified as Side Panel to Edge Panel hold back weld at work point E6.

identification was 050789 and was observed welding in the 4G (Overhead) position using approved Welding Procedure Specification WPS-B-P-2214-Tc-U4b-FCM-1. The piece mark was identified as Side Panel to Edge Panel hold back weld at work point E6.

This QA Inspector observed the in-process welding by Shielded Metal Arc Welding (SMAW) process on a Complete Joint Penetration (CJP) groove weld. The Weld joint was designated as CA6502-012. The welder identification was 040458 and was observed welding in the 1G (Flat) position using approved Welding Procedure Specification WPS-B-T-2231T-ESAB. The piece mark was identified as the Deck Panel Corner Assembly, transverse splice weld.

This QA Inspector observed the in-process welding by Flux Cored Arc Welding (FCAW) process on a Complete Joint Penetration (CJP) groove weld. The Weld joint was designated as SP3017-001-040. The welder identification was 046709 and observed welding in the 3G (Vertical) position using approved Welding Procedure Specification WPS-B-T-2233-ESAB. The piece mark was identified as the T-Ribs splice weld at Bike Path side.
