DEPARTMENT OF TRANSPORTATION

Quality Assurance and Source Inspection

Contract #: 04-0120F4Cty: SF/ALA Rte: 80 PM: 13.2/13.9File #: 69.28**WELDING INSPECTION REPORT****Resident Engineer:** Siegenthaler, Peter**Address:** 333 Burma Road**City:** Oakland, CA 94607**Report No:** WIR-019243**Date Inspected:** 14-Jan-2011**Project Name:** SAS Superstructure**OSM Arrival Time:** 700**Prime Contractor:** American Bridge/Fluor Enterprises, a JV**OSM Departure Time:** 1900**Contractor:** Zhenhua Port Machinery Company, Ltd (ZPMC), Changxing Island **Location:** Shanghai, China**CWI Name:** Liu Hua Jie**CWI Present:** Yes No**Inspected CWI report:** Yes No N/A**Rod Oven in Use:** Yes No N/A**Electrode to specification:** Yes No N/A**Weld Procedures Followed:** Yes No N/A**Qualified Welders:** Yes No N/A**Verified Joint Fit-up:** Yes No N/A**Approved Drawings:** Yes No N/A**Approved WPS:** Yes No N/A**Delayed / Cancelled:** Yes No N/A**Bridge No:** 34-0006**Component:** Orthotropic Box Girder (OBG)**Summary of Items Observed:**

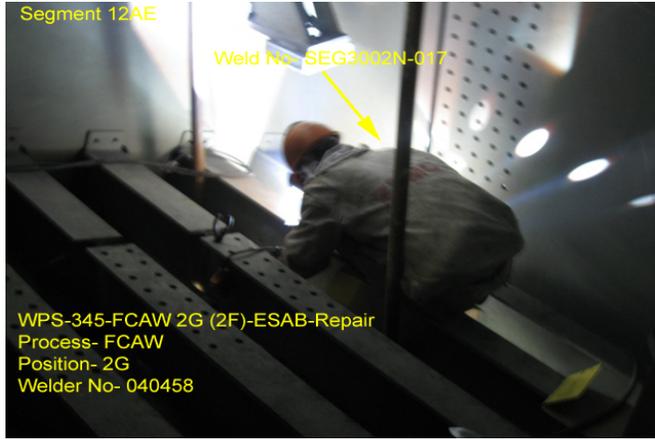
This QA Inspector observed ZPMC qualified welding personnel identified as 046704 perform Flux Core Arc Welding (FCAW), weld joint identified as SEG3002N-017; located On Orthotropic Box Girder (OBG) Bottom Plate to Longitudinal Diaphragm CJP Weld; The Welding Repair Report (WRR) was B-WR20105. ZPMC Quality Control (QC) is identified as Mr. Liu Hua Jie. The welding variables recorded by QC appeared to comply with applicable WPS-345-FCAW 2G (2F) ESAB-Repair. See attached photo for further details.
