DEPARTMENT OF TRANSPORTATION

Quality Assurance and Source Inspection

Contract #: 04-0120F4Cty: SF/ALA Rte: 80 PM: 13.2/13.9File #: 99.28**WELDING INSPECTION REPORT****Resident Engineer:** Siegenthaler, Peter**Address:** 333 Burma Road**City:** Oakland, CA 94607**Report No:** WIR-019299**Date Inspected:** 18-Jan-2011**Project Name:** SAS Superstructure**OSM Arrival Time:** 700**Prime Contractor:** American Bridge/Fluor Enterprises, a JV**OSM Departure Time:** 1900**Contractor:** Zhenhua Port Machinery Company, Ltd (ZPMC)**Location:** Shanghai, China**CWI Name:** Li Yang and Zhu Zhong Hai**CWI Present:** Yes No**Inspected CWI report:** Yes No N/A**Rod Oven in Use:** Yes No N/A**Electrode to specification:** Yes No N/A**Weld Procedures Followed:** Yes No N/A**Qualified Welders:** Yes No N/A**Verified Joint Fit-up:** Yes No N/A**Approved Drawings:** Yes No N/A**Approved WPS:** Yes No N/A**Delayed / Cancelled:** Yes No N/A**Bridge No:** 34-0006**Component:** OBG Trial Assembly**Summary of Items Observed:**

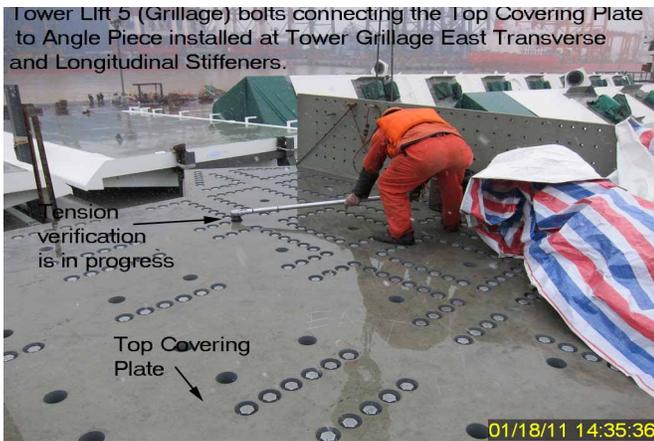
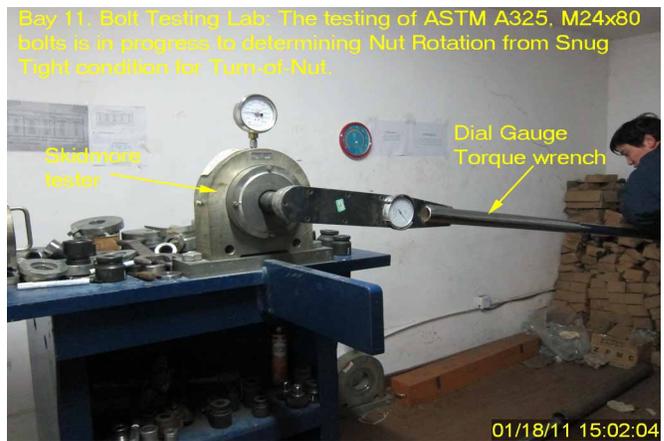
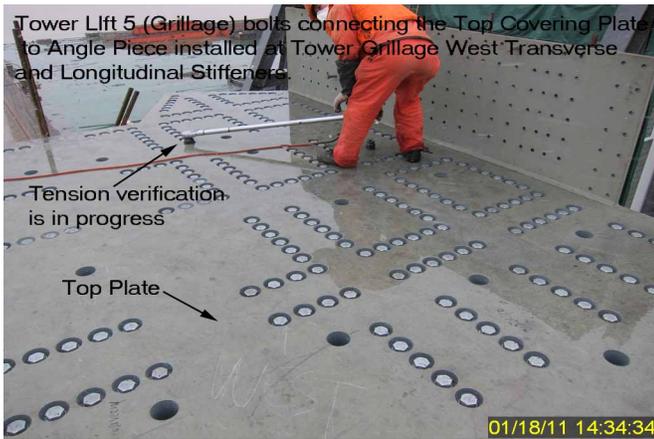
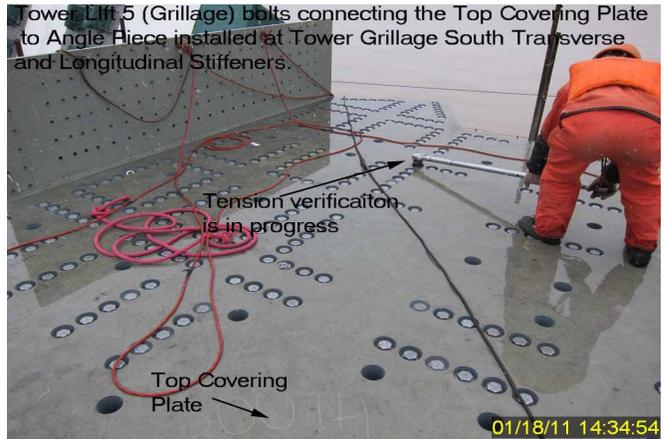
This QA Inspector witnessed final bolt tension verification on bolts connecting the Top Covering Plate to Angle Piece installed at Tower Grillage East Transverse and Longitudinal Stiffeners and Angle Piece installed at stiffeners “A Line” and “E Line”. Inspected the bolt tensioning on a random basis. The Inspection was performed against Notification No. 00615 dated January 18, 2011.

This QA Inspector witnessed final bolt tension verification on bolts connecting the Top Covering Plate to Angle Piece installed at Tower Grillage West Transverse and Longitudinal Stiffeners and Angle Piece installed at stiffeners “A Line” and “E Line”. Inspected the bolt tensioning on a random basis. The Inspection was performed against Notification No. 00615 dated January 18, 2011.

This QA Inspector witnessed final bolt tension verification on bolts connecting the Top Covering Plate to Angle Piece installed at Tower Grillage South Transverse and Longitudinal Stiffeners and Angle Piece installed at stiffeners “A Line” and “E Line”. Inspected the bolt tensioning on a random basis. The Inspection was performed against Notification No. 00615 dated January 18, 2011.

This QA Inspector witnessed final bolt tension verification on bolts connecting the Top Covering Plate to Angle Piece installed at Tower Grillage North Transverse and Longitudinal Stiffeners and Angle Piece installed at stiffeners “A Line” and “E Line”. Inspected the bolt tensioning on a random basis. The Inspection was performed against Notification No. 00615 dated January 18, 2011.

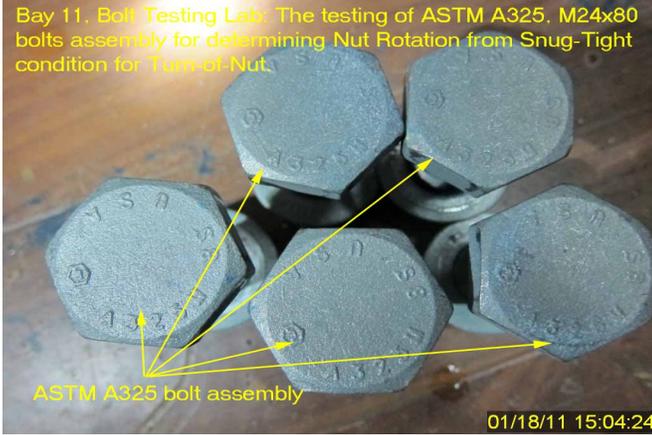
Bay 11. Bolt Testing Lab: The testing of ASTM A325, M24x80 bolts assembly for determining Nut Rotation from Snug-Tight condition for Turn-of-Nut.

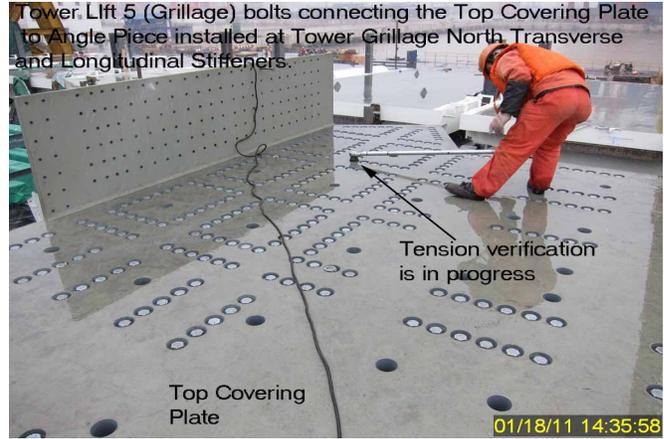
Tower Lift 5 (Grillage) bolts connecting the Top Covering Plate to Angle Piece installed at Tower Grillage North Transverse and Longitudinal Stiffeners.
