DEPARTMENT OF TRANSPORTATION

Contract #: 04-0120F4Cty: SF/ALA Rte: 80 PM: 13.2/13.9File #: 99.28**WELDING INSPECTION REPORT****Resident Engineer:** Siegenthaler, Peter**Address:** 333 Burma Road**City:** Oakland, CA 94607**Report No:** WIR-019304**Date Inspected:** 13-Jan-2011**Project Name:** SAS Superstructure**OSM Arrival Time:** 700**Prime Contractor:** American Bridge/Fluor Enterprises, a JV**OSM Departure Time:** 1900**Contractor:** Zhenhua Port Machinery Company, Ltd (ZPMC)**Location:** Shanghai, China**CWI Name:** Li Yang and Zhu Zhong Hai**CWI Present:** Yes No**Inspected CWI report:** Yes No N/A**Rod Oven in Use:** Yes No N/A**Electrode to specification:** Yes No N/A**Weld Procedures Followed:** Yes No N/A**Qualified Welders:** Yes No N/A**Verified Joint Fit-up:** Yes No N/A**Approved Drawings:** Yes No N/A**Approved WPS:** Yes No N/A**Delayed / Cancelled:** Yes No N/A**Bridge No:** 34-0006**Component:** OBG Trial Assembly**Summary of Items Observed:**

Orthotropic Box Girder (OBG) at Trial Assembly Areas

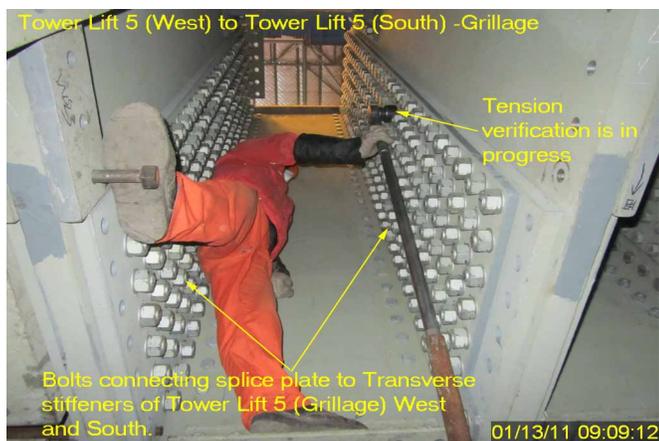
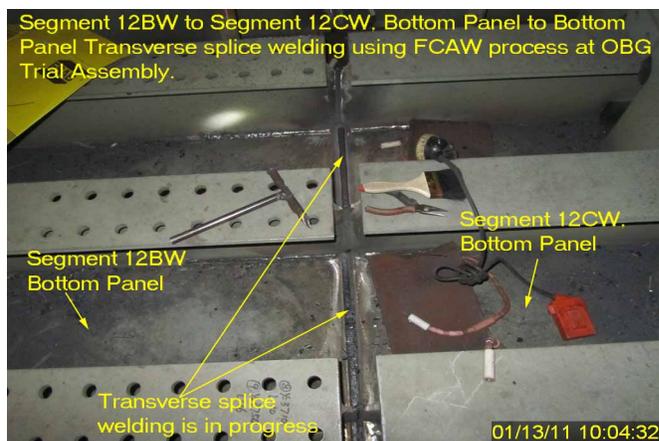
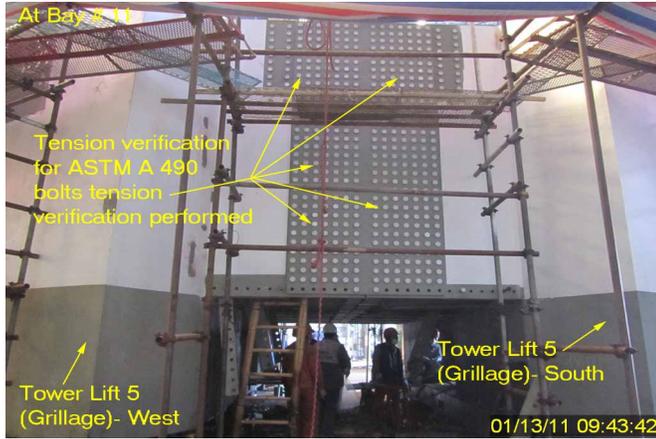
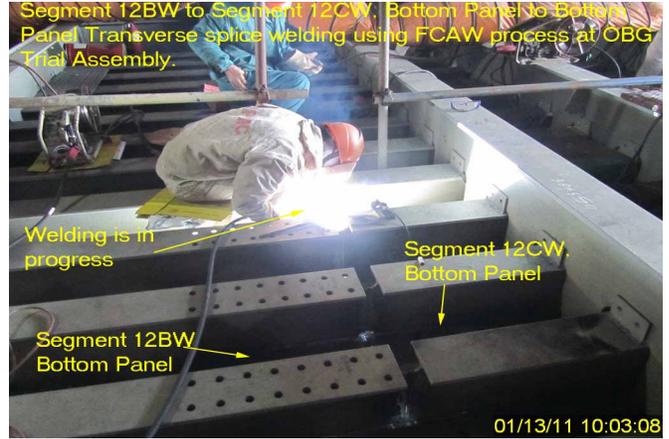
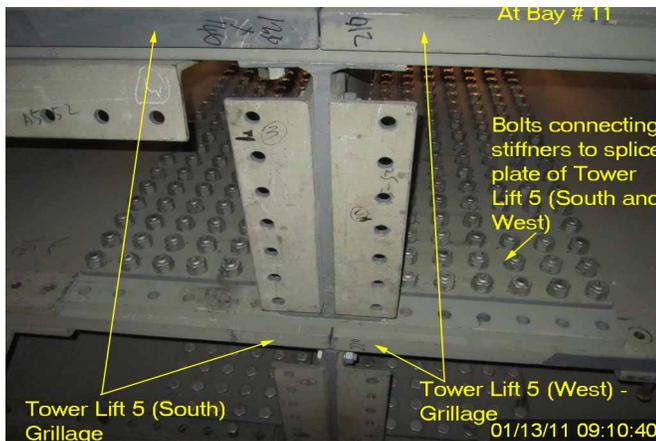
This QA Inspector witnessed final bolt tension verification on bolts connecting the South Tower Lift 5 (Grillage) to West Tower Lift 5 (Grillage) splice plate at Line A. Inspected the bolt tensioning on a random basis and found the tension to be in general compliance. Inspection was performed against the Notification No. 00610 Dated January 13, 2011.

This QA Inspector observed the in-process welding by Flux Cored Arc Welding (FCAW) process on a Complete Joint Penetration (CJP) groove weld. The Weld joint was designated as OBW12E-002. The welder identification was 049220 and observed welding in the 3G (Vertical) position using approved Welding Procedure Specification WPS-B-T-2233T-ESAB. The piece mark was identified as the Side Panel, Cross Beam side at transverse splice.

This QA Inspector observed the in-process welding by Flux Cored Arc Welding (FCAW) process on a Complete Joint Penetration (CJP) groove weld. The Weld joint was designated as OBE12C-001. The welder identification was 053486 and 040736 and observed welding in the 1G (Flat) position using approved Welding Procedure

This QA Inspector observed the in-process welding by Flux Cored Arc Welding (FCAW) process on a Complete Joint Penetration (CJP) groove weld. The Weld joint was designated as OBW12E-001. The welder identification was 040759 and observed welding in the 3G (Vertical) position using approved Welding Procedure Specification WPS-B-T-2233T-ESAB. The piece mark was identified as the Side Panel, Counter Weight side at transverse splice.

This QA Inspector observed the in-process welding by Shielded Metal Arc Welding (SMAW) process on a Complete Joint Penetration (CJP) groove weld. The Weld joint was designated as CA3002-006. The welder identification was 050289 and was observed welding in the 4G (Overhead) position using approved Welding Procedure Specification WPS-B-P-2214-Tc-U4b-FCM-1. The piece mark was identified as weld connecting Deck Panel to Edge Panel hold back weld at work point E5.

This QA Inspector observed the in-process welding by Shielded Metal Arc Welding (SMAW) process on a Complete Joint Penetration (CJP) groove weld. The Weld joint was designated as CA3004-002. The welder identification was 050289 and was observed welding in the 4G (Overhead) position using approved Welding Procedure Specification WPS-B-P-2214-Tc-U4b-FCM-1. The piece mark was identified as weld connecting Deck Panel to Edge Panel hold back weld at work point E2.
