DEPARTMENT OF TRANSPORTATION

Quality Assurance and Source Inspection

Contract #: 04-0120F4Cty: SF/Ala Rte: 80 PM: 13.2/13.9File #: 69.28**WELDING INSPECTION REPORT****Resident Engineer:** Siegenthaler, Peter**Address:** 333 Burma Road**City:** Oakland, CA 94607**Report No:** WIR-019358**Date Inspected:** 04-Jan-2011**Project Name:** SAS Superstructure**OSM Arrival Time:** 1900**Prime Contractor:** American Bridge/Fluor Enterprises, a JV**OSM Departure Time:** 700**Contractor:** Zhenhua Port Machinery Company, Ltd (ZPMC), Changxing Island **Location:** Shanghai, China**CWI Name:** See below**CWI Present:** Yes No**Inspected CWI report:** Yes No N/A**Rod Oven in Use:** Yes No N/A**Electrode to specification:** Yes No N/A**Weld Procedures Followed:** Yes No N/A**Qualified Welders:** Yes No N/A**Verified Joint Fit-up:** Yes No N/A**Approved Drawings:** Yes No N/A**Approved WPS:** Yes No N/A**Delayed / Cancelled:** Yes No N/A**Bridge No:** 34-0006**Component:** Tower and OBG Components**Summary of Items Observed:**

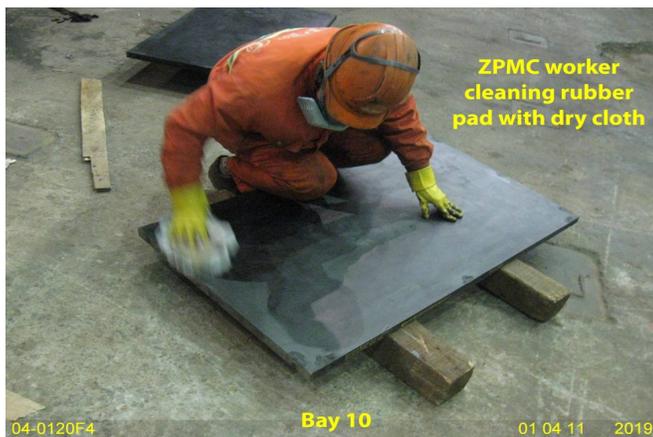
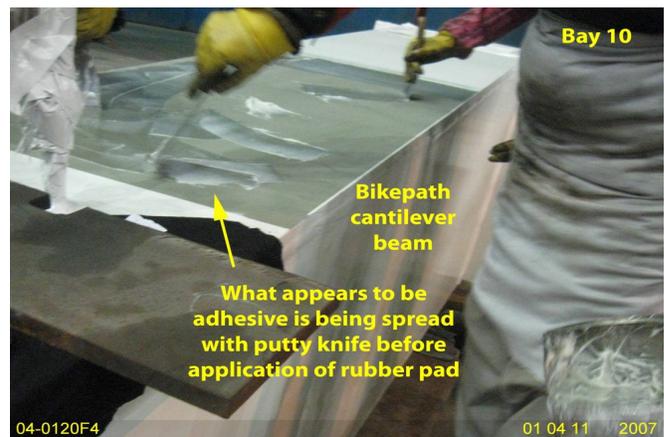
ZPMC workers were gluing 30mm x 700mm x 1283mm rubber pads to the top surface of OBG bikepath cantilever

beams. As the pads were removed from a crate, they were wiped clean with a cloth. A pasty adherent was spread on the zinc coated surfaces of the cantilever beam with a putty knife before the pads were applied. After placing the pads, the pads were covered with cloth and scrap pieces of steel were laid on top to apply pressure. See photos below.
