**DEPARTMENT OF TRANSPORTATION**

Contract #: 04-0120F4Cty: SF/ALA Rte: 80 PM: 13.2/13.9File #: 69.28**WELDING INSPECTION REPORT****Resident Engineer:** Siegenthaler, Peter**Address:** 333 Burma Road**City:** Oakland, CA 94607**Report No:** WIR-019417**Date Inspected:** 16-Jan-2011**Project Name:** SAS Superstructure**OSM Arrival Time:** 700**Prime Contractor:** American Bridge/Fluor Enterprises, a JV**OSM Departure Time:** 1900**Contractor:** Zhenhua Port Machinery Company, Ltd (ZPMC), Changxing Island **Location:** Shanghai, China**CWI Name:** Mr. An Qing xiang**CWI Present:** Yes No**Inspected CWI report:** Yes No N/A**Rod Oven in Use:** Yes No N/A**Electrode to specification:** Yes No N/A**Weld Procedures Followed:** Yes No N/A**Qualified Welders:** Yes No N/A**Verified Joint Fit-up:** Yes No N/A**Approved Drawings:** Yes No N/A**Approved WPS:** Yes No N/A**Delayed / Cancelled:** Yes No N/A**Bridge No:** 34-0006**Component:** Orthotropic Box Girder (OBG)**Summary of Items Observed:**

# WELDING INSPECTION REPORT

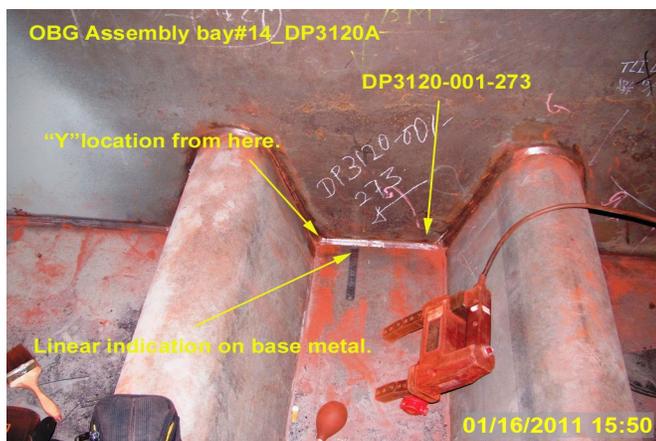
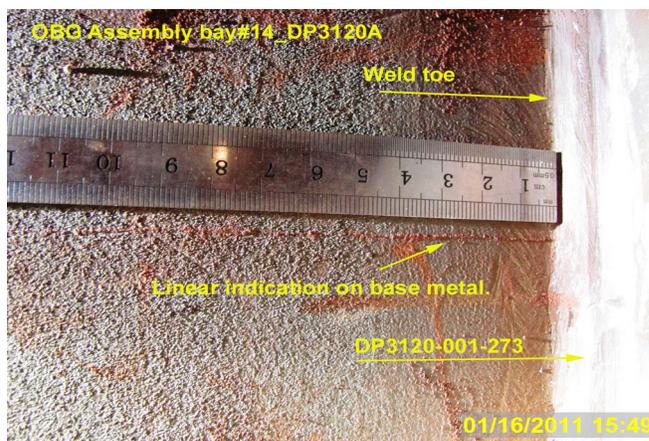
During QA MT review of welds located on OBG Lift 13AW Deck plate DP3120A, this QA observed one transverse surface linear indication on base metal. The nearest weld is identified as: DP3120-001-273. The “Y” location is approximately 100 mm as shown on the picture below. This QA Inspector informed to Lead QA Inspector for the above issue. Refer the attached photos for reference.
