**DEPARTMENT OF TRANSPORTATION**

Contract #: 04-0120F4Cty: SF/ALA Rte: 80 PM: 13.2/13.9File #: 69.28**WELDING INSPECTION REPORT****Resident Engineer:** Siegenthaler, Peter**Address:** 333 Burma Road**City:** Oakland, CA 94607**Report No:** WIR-019430**Date Inspected:** 21-Jan-2011**Project Name:** SAS Superstructure**OSM Arrival Time:** 1500**Prime Contractor:** American Bridge/Fluor Enterprises, a JV**OSM Departure Time:** 300**Contractor:** Zhenhua Port Machinery Company, Ltd (ZPMC), Changxing Island **Location:** Shanghai, China**CWI Name:** Liu Fa Wen**CWI Present:** Yes No**Inspected CWI report:** Yes No N/A**Rod Oven in Use:** Yes No N/A**Electrode to specification:** Yes No N/A**Weld Procedures Followed:** Yes No N/A**Qualified Welders:** Yes No N/A**Verified Joint Fit-up:** Yes No N/A**Approved Drawings:** Yes No N/A**Approved WPS:** Yes No N/A**Delayed / Cancelled:** Yes No N/A**Bridge No:** 34-0006**Component:** OBG**Summary of Items Observed:**

# WELDING INSPECTION REPORT

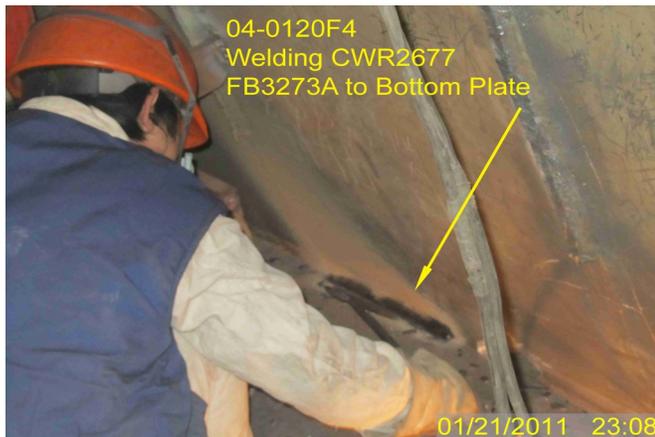
Weld- SEG3019E-1-182 (CWR2677)

WPS-345-SMAW-2G(2F)-FCM-Repair-1

Welder-044830

2G/SMAW/ CJP

The following digital picture illustrates welder #044830 welding CWR2677.
