**DEPARTMENT OF TRANSPORTATION**

Contract #: 04-0120F4Cty: SF/ALA Rte: 80 PM: 13.2/13.9File #: 1.28**WELDING INSPECTION REPORT****Resident Engineer:** Siegenthaler, Peter**Address:** 333 Burma Road**City:** Oakland, CA 94607**Report No:** WIR-019476**Date Inspected:** 25-Jan-2011**Project Name:** SAS Superstructure**OSM Arrival Time:** 1000**Prime Contractor:** American Bridge/Fluor Enterprises, a JV**OSM Departure Time:** 2230**Contractor:** American Bridge/Fluor Enterprises, a JV**Location:** Job Site

## WELDING INSPECTION REPORT

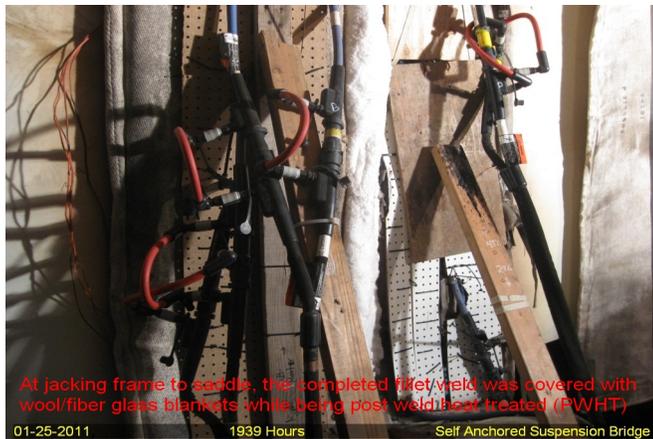
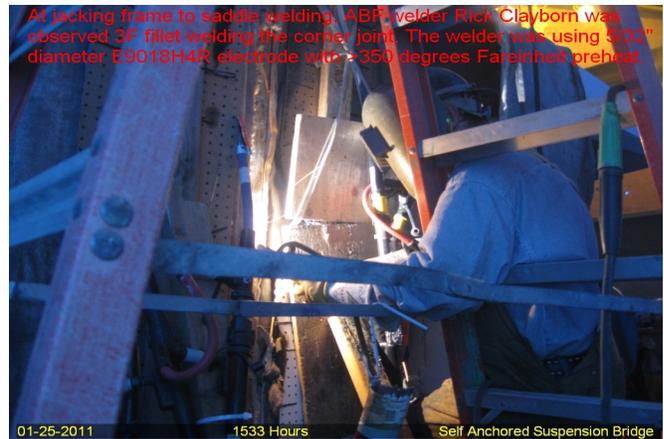
At Jacking Frame to Saddle fillet welding, the highlights of the welding and post weld heat treatment (PWHT) that transpired during QA observations were the following;

3. After the completion of the sixth cover pass, the welder wire brushed the fillet weld and ABF QC Mike Johnson performed the visual test (VT) and using a 25mm fillet weld gauge, measured the weld. During the VT, QC noted underfill and undercut which the welder has fixed. Final fillet welding was completed at 1640hours.

4. After the final welding was completed, ABF QC Mike Johnson performed VT and using a 25mm fillet gauge, QC measured the size of the fillet weld and accepted it.

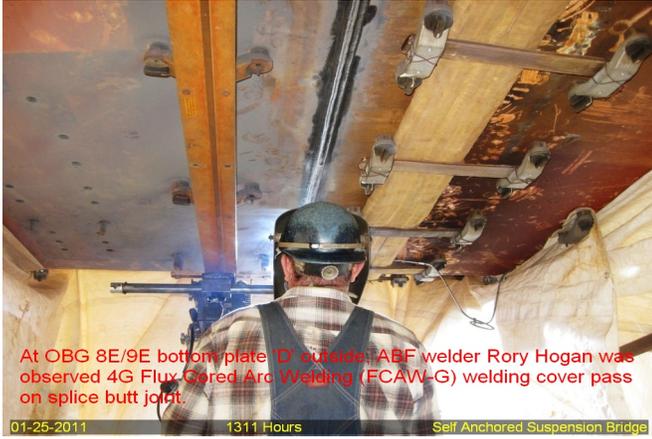
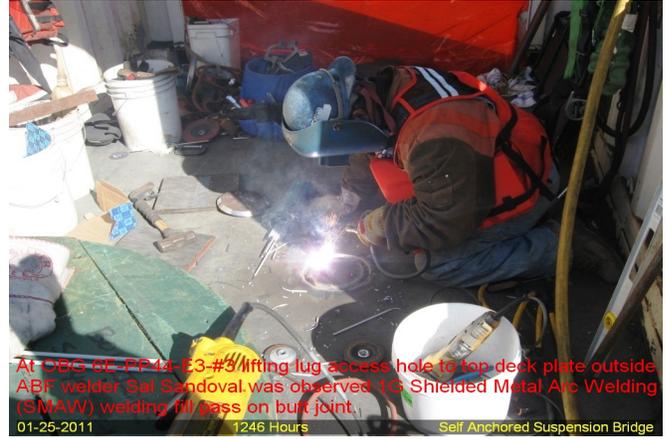
6. The preparation for the PWHT started as soon as the weld was completed. ABF personnel were noted covering the weld joint with fiber glass/wool covering. ABF personnel Ben Jones was noted programming the machines to 390 degrees F/hour heating rate during the prep.

7. The following temperatures were noted on four Miller Proheat 35 Induction Heating System during the heating and holding period of the joint;
