Contract #: 04-0120F4Cty: SF/ALA Rte: 80 PM: 13.2/13.9File #: 99.28**WELDING INSPECTION REPORT****Resident Engineer:** Siegenthaler, Peter**Address:** 333 Burma Road**City:** Oakland, CA 94607**Report No:** WIR-019478**Date Inspected:** 22-Jan-2011**Project Name:** SAS Superstructure**OSM Arrival Time:** 700**Prime Contractor:** American Bridge/Fluor Enterprises, a JV**OSM Departure Time:** 1900**Contractor:** Zhenhua Port Machinery Company, Ltd (ZPMC)**Location:** Shanghai, China**CWI Name:** Li Yang and Zhu Zhong Hai**CWI Present:** Yes No**Inspected CWI report:** Yes No N/A**Rod Oven in Use:** Yes No N/A**Electrode to specification:** Yes No N/A**Weld Procedures Followed:** Yes No N/A**Qualified Welders:** Yes No N/A**Verified Joint Fit-up:** Yes No N/A**Approved Drawings:** Yes No N/A**Approved WPS:** Yes No N/A**Delayed / Cancelled:** Yes No N/A**Bridge No:** 34-0006**Component:** OBG Trial Assembly**Summary of Items Observed:**

Orthotropic Box Girder (OBG) at Trial Assembly Areas

WELDING INSPECTION REPORT

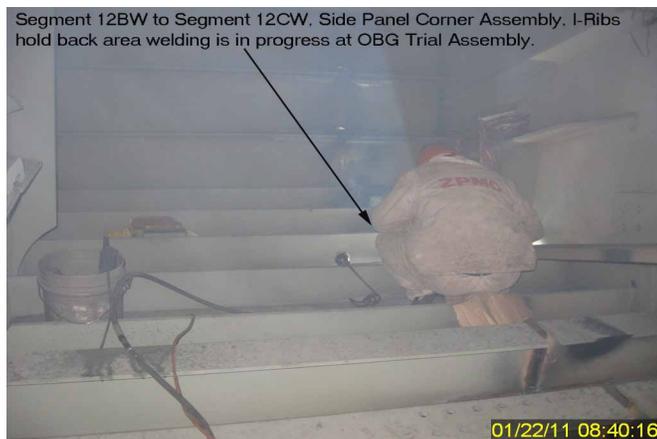
This QA Inspector observed the in-process welding by Shielded Metal Arc Welding (SMAW) process on a Complete Joint Penetration (CJP) groove weld. The Weld joint was designated as Seg3005A-004. The welder identification was 046704 and was observed welding in the 4G (Overhead) position using approved Welding Procedure Specification WPS-B-P-2214-B-U2-FCM-1. The piece mark was identified as weld connecting Bottom Panel to Side Panel hold back weld at work point W4.

This QA Inspector observed the in-process welding by Shielded Metal Arc Welding (SMAW) process on a Complete Joint Penetration (CJP) groove weld. The Weld joint was designated as Seg3006A-011. The welder identification was 046704 and was observed welding in the 4G (Overhead) position using approved Welding Procedure Specification WPS-B-P-2214-B-U2-FCM-1. The piece mark was identified as weld connecting Bottom

This QA Inspector observed the in-process welding by Shielded Metal Arc Welding (SMAW) process on a Complete Joint Penetration (CJP) groove weld. The Weld joint was designated as Seg3005A-003. The welder identification was 040611 and was observed welding in the 4G (Overhead) position using approved Welding Procedure Specification WPS-B-P-2214-B-U2-FCM-1. The piece mark was identified as weld connecting Bottom Panel to Side Panel hold back weld at work point W3.

This QA Inspector observed the in-process welding by Shielded Metal Arc Welding (SMAW) process on a Complete Joint Penetration (CJP) groove weld. The Weld joint was designated as Seg3006A-012. The welder identification was 040611 and was observed welding in the 4G (Overhead) position using approved Welding Procedure Specification WPS-B-P-2214-B-U2-FCM-1. The piece mark was identified as weld connecting Bottom Panel to Side Panel hold back weld at work point W3.

This QA Inspector observed the in-process welding by Shielded Metal Arc Welding (SMAW) process on a Complete Joint Penetration (CJP) groove weld. The Weld joint was designated as SP3039-001-049. The welder identification was 041713 observed welding in the 3G (Vertical) position using approved Welding Procedure Specification WPS-B-P-2213-B-U2-FCM-1. The piece mark was identified as the Side Panel Corner Assembly, I-Rib splice, Cross Beam side.

This QA Inspector observed the in-process welding by Shielded Metal Arc Welding (SMAW) process on a Complete Joint Penetration (CJP) groove weld. The Weld joint was designated as SP3051-001-038. The welder identification was 046709 observed welding in the 4G (Overhead) position using approved Welding Procedure Specification WPS-B-P-2214-B-U2-FCM-1. The piece mark was identified as the Side Panel Corner Assembly, I-Rib splice, Counter Weight side.

This QA Inspector observed the in-process welding by Shielded Metal Arc Welding (SMAW) process on a Complete Joint Penetration (CJP) groove weld. The Weld joint was designated as SP3052-001-048. The welder identification was 046709 observed welding in the 4G (Overhead) position using approved Welding Procedure Specification WPS-B-P-2214-B-U2-FCM-1. The piece mark was identified as the Side Panel Corner Assembly, I-Rib splice, Counter Weight side.

This QA Inspector observed that ZPMC Ship # Zhen Hua # 18 has left from Jetty # 5 from ZPMC Changxing Island, Shanghai, China to en-route to Yerba Buena Island, California, USA.
