DEPARTMENT OF TRANSPORTATION

Quality Assurance and Source Inspection

Contract #: 04-0120F4Cty: SF/Ala Rte: 80 PM: 13.2/13.9File #: 69.28**WELDING INSPECTION REPORT****Resident Engineer:** Siegenthaler, Peter**Address:** 333 Burma Road**City:** Oakland, CA 94607**Report No:** WIR-019612**Date Inspected:** 21-Jan-2011**Project Name:** SAS Superstructure**OSM Arrival Time:** 1900**Prime Contractor:** American Bridge/Fluor Enterprises, a JV**OSM Departure Time:** 700**Contractor:** Zhenhua Port Machinery Company, Ltd (ZPMC), Changxing Island **Location:** Shanghai, China**CWI Name:** See below**CWI Present:** Yes No**Inspected CWI report:** Yes No N/A**Rod Oven in Use:** Yes No N/A**Electrode to specification:** Yes No N/A**Weld Procedures Followed:** Yes No N/A**Qualified Welders:** Yes No N/A**Verified Joint Fit-up:** Yes No N/A**Approved Drawings:** Yes No N/A**Approved WPS:** Yes No N/A**Delayed / Cancelled:** Yes No N/A**Bridge No:** 34-0006**Component:** OBG Components**Summary of Items Observed:**

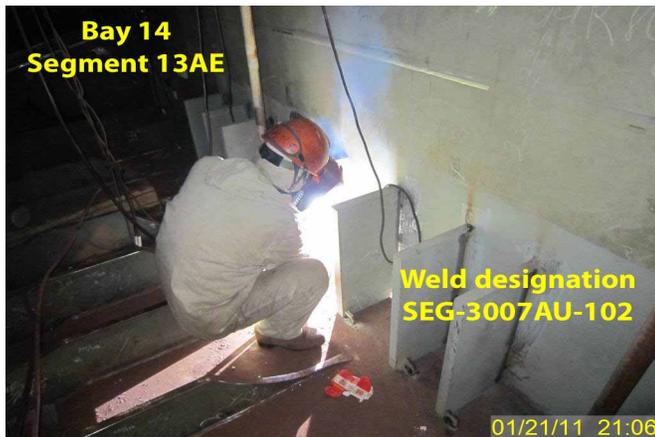
FCAW welding of weld joint SEG-3007AU-102 located on PCMK OBG segment 13AE. Welder was identified as 066733. QC was identified as QC1. Weld variables recorded by QC1 appeared to comply with WPS-B-T-2233-ESAB as verbally identified by QC1. See photo below.
