DEPARTMENT OF TRANSPORTATION

Contract #: 04-0120F4Cty: SF/ALA Rte: 80 PM: 13.2/13.9File #: 69.28**WELDING INSPECTION REPORT****Resident Engineer:** Siegenthaler, Peter**Address:** 333 Burma Road**City:** Oakland, CA 94607**Report No:** WIR-019771**Date Inspected:** 15-Jan-2011**Project Name:** SAS Superstructure**OSM Arrival Time:** 1500**Prime Contractor:** American Bridge/Fluor Enterprises, a JV**OSM Departure Time:** 300**Contractor:** Zhenhua Port Machinery Company, Ltd (ZPMC), Changxing Island **Location:** Shanghai, China**CWI Name:** See Below**CWI Present:** Yes No**Inspected CWI report:** Yes No N/A**Rod Oven in Use:** Yes No N/A**Electrode to specification:** Yes No N/A**Weld Procedures Followed:** Yes No N/A**Qualified Welders:** Yes No N/A**Verified Joint Fit-up:** Yes No N/A**Approved Drawings:** Yes No N/A**Approved WPS:** Yes No N/A**Delayed / Cancelled:** Yes No N/A**Bridge No:** 34-0006**Component:** OBG**Summary of Items Observed:**

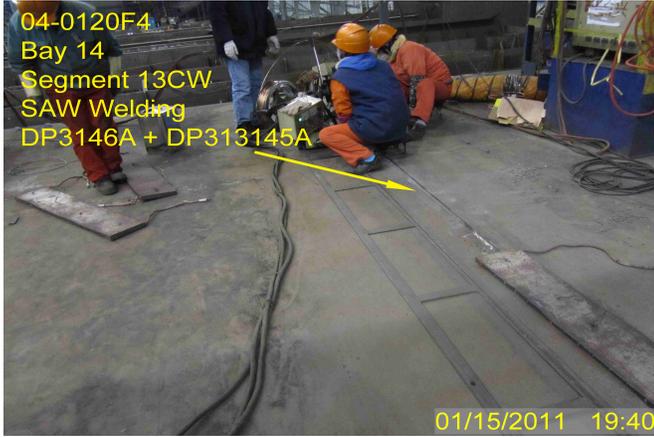
This QA inspector performed a random observation for the Orthotropic Bridge Girders (OBG) located at ZPMC Shanghai China. During the observation performed it was noted that at Bay 14, ZPMC was in process of welding on segment 13CW. ZPMC QC inspector Wang Xiang Pin was present at this time of this observation and informed this QA inspector of the work that is in process, and identified Qiu Wen as the CWI. It was stated that ZPMC had 2 welders and identified the welders by ZPMC welder identification number appointed to then by ZPMC. This QA inspector verified this information for the following location;

The following digital picture illustrates SAW in progress.
