**DEPARTMENT OF TRANSPORTATION**

Quality Assurance and Source Inspection

Contract #: 04-0120F4Cty: SF/ALA Rte: 80 PM: 13.2/13.9File #: 69.28**WELDING INSPECTION REPORT****Resident Engineer:** Siegenthaler, Peter**Address:** 333 Burma Road**City:** Oakland, CA 94607**Report No:** WIR-019786**Date Inspected:** 18-Dec-2010**Project Name:** SAS Superstructure**OSM Arrival Time:** 1900**Prime Contractor:** American Bridge/Fluor Enterprises, a JV**OSM Departure Time:** 700**Contractor:** Zhenhua Port Machinery Company, Ltd (ZPMC), Changxing Island **Location:** Shanghai, China**CWI Name:** See below**CWI Present:** Yes No**Inspected CWI report:** Yes No N/A**Rod Oven in Use:** Yes No N/A**Electrode to specification:** Yes No N/A**Weld Procedures Followed:** Yes No N/A**Qualified Welders:** Yes No N/A**Verified Joint Fit-up:** Yes No N/A**Approved Drawings:** Yes No N/A**Approved WPS:** Yes No N/A**Delayed / Cancelled:** Yes No N/A**Bridge No:** 34-0006**Component:** OBG**Summary of Items Observed:**

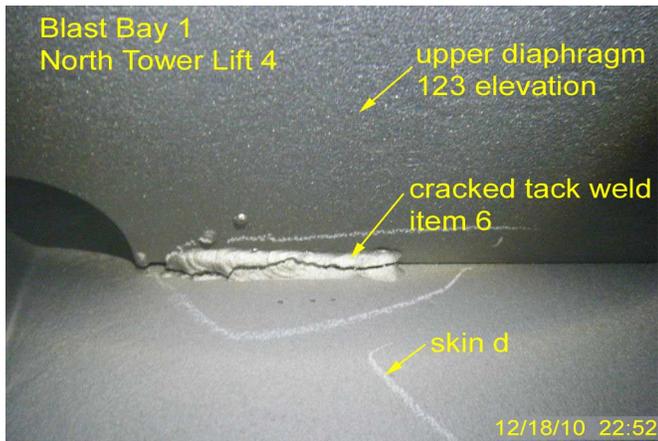
This Caltrans QA Inspector performed a pre-blast visual inspection of the interior surface and internal components, Lift 4, NSDI tower subassembly, 116~131 meter mark to the bottom surface of the double diaphragm. Surface defects and base metal surface irregularities that required grinding were marked up with colored chalk, and weld defects that require welding were taped with gray masking tape for repair after the coating has been applied. ZPMC QC and ABF inspection personnel were present during the inspection and informed of QA findings. ( see picture below )
