**DEPARTMENT OF TRANSPORTATION**

Contract #: 04-0120F4Cty: SF/ALA Rte: 80 PM: 13.2/13.9File #: 1.28**WELDING INSPECTION REPORT****Resident Engineer:** Siegenthaler, Peter**Address:** 333 Burma Road**City:** Oakland, CA 94607**Report No:** WIR-019814**Date Inspected:** 28-Jan-2011**Project Name:** SAS Superstructure**OSM Arrival Time:** 900**Prime Contractor:** American Bridge/Fluor Enterprises, a JV**OSM Departure Time:** 1730**Contractor:** American Bridge/Fluor Enterprises, a JV**Location:** Job Site

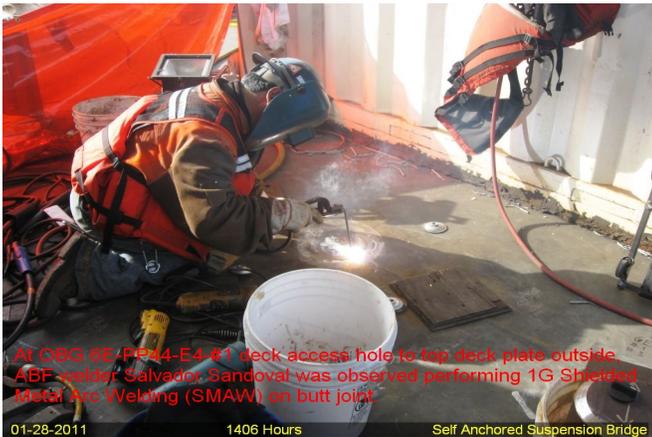
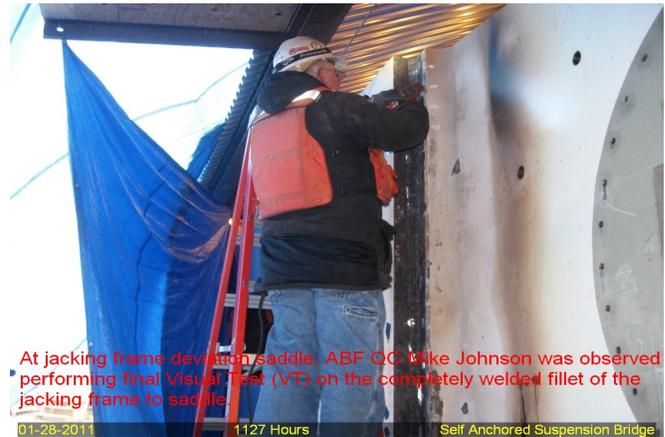
At OBG 6E-PP44-E4-#1 lifting lug access hole to top deck outside, ABF welder Salvador Sandoval was observed continuing to perform 1G Shielded Metal Arc Welding (SMAW) welding fill pass to cover pass on the infill plate to top deck plate butt joint. The welder was noted using 1/8” diameter E7018H4R electrode implementing Caltrans approved Welding Procedure Specification (WPS) ABF-WPS-D15-1070. During welding, ABF Quality Control (QC) Steve Mc Connell was noted monitoring the welding parameters of the welder. At the end of the shift, cover pass welding was completed and the welder was noted preparing to move to hole #2 of the same location.
