Contract #: 04-0120F4Cty: SF/ALA Rte: 80 PM: 13.2/13.9File #: 1.28**WELDING INSPECTION REPORT****Resident Engineer:** Siegenthaler, Peter**Address:** 333 Burma Road**City:** Oakland, CA 94607**Report No:** WIR-019816**Date Inspected:** 25-Jan-2011**Project Name:** SAS Superstructure**OSM Arrival Time:** 630**Prime Contractor:** American Bridge/Fluor Enterprises, a JV**OSM Departure Time:** 1500**Contractor:** American Bridge/Fluor Enterprises, a JV**Location:** Job Site**CWI Name:** See below**CWI Present:** Yes No**Inspected CWI report:** Yes No N/A**Rod Oven in Use:** Yes No N/A**Electrode to specification:** Yes No N/A**Weld Procedures Followed:** Yes No N/A**Qualified Welders:** Yes No N/A**Verified Joint Fit-up:** Yes No N/A**Approved Drawings:** Yes No N/A**Approved WPS:** Yes No N/A**Delayed / Cancelled:** Yes No N/A**Bridge No:** 34-0006**Component:** SAS OBG**Summary of Items Observed:**

Jacking Frame to Saddle fillet weld (East side)

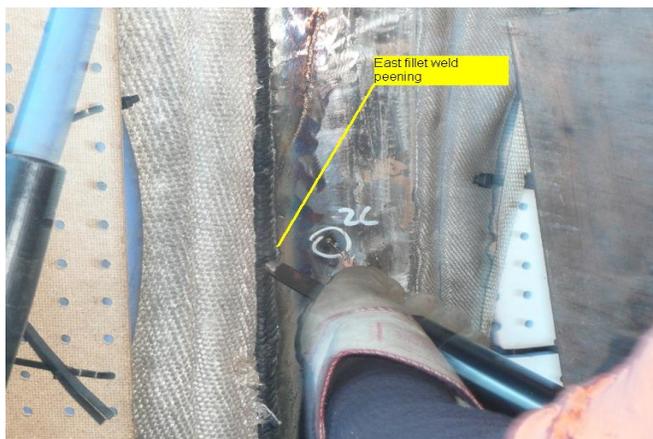
general compliance with the approved WPS. The QA Inspector noted the ABF welder completed the second weld pass at 0945. The QA Inspector noted the weld joint and surrounding material appeared to be approximately 380°F. The QA Inspector periodically observed the temperature of the casting behind the weld joint. The QA Inspector noted the temperature behind the weld joint on the 415 casting appeared to be approximately 40°-50°F higher than that in the weld joint or surrounding material. In addition the QA Inspector randomly checked the 485W HPS material on the jacking frame side of the weld joint. The QA Inspector noted due to the configuration of the induction heating blankets the QA Inspector was only able to check the temperature under the jacking frame approximately 12” from the weld joint. The QA Inspector noted temperature at the location described above maintained approximately 320°F through out the duration of the first three passes. After the second pass was completed the QA Inspector observed the contractor begin peening utilizing a pneumatic air chisel with a 6mm radius bit. It was observed the peening technique did appear to indent or elongate the weld pass with sufficient force to satisfy the code requirement. At 1020 the QA Inspector observed the ABF welder begin the third pass and continued utilizing 5/32” electrodes with approximately 158Amps. The QA Inspector randomly observed the third weld pass was completed at 1122. The QA Inspector noted the temperature appeared to stay around 380°-400°F. After the peening was completed the QA Inspector noted the fourth pass was stated at 1130. The QA Inspector randomly observed the SE QC Inspector perform dimensional measurements of the weld size and he informed the QA ABF welder and the QA Inspector the weld would need one to two additional passes to complete the required minimum fillet weld size. The QA Inspector noted the SMAW parameters did not vary from above. The QA Inspector observed the SE QC Inspector utilize the Fluke averaging meter and determine the average voltage used was approximately 23 Volts. The QA Inspector calculated the heat input value utilizing 100mm/min and determined the heat input value to be approximately 2.1kj/mm and did appear to be within the minimum and maximum heat input range of the above specified WPS. The QA Inspector noted the fourth pass was completed at 1315 and peening was immediately performed. At 1350 the first of two cover passes was started utilizing 5/32” electrodes with the approximately the same parameters utilized above. The QA Inspector noted the METS QA Inspector Joselito Lizardo relieved the QA Inspector at the above identified location for the remainder of the welding and the Post weld heat treatment.
