DEPARTMENT OF TRANSPORTATION

Contract #: 04-0120F4Cty: SF/ALA Rte: 80 PM: 13.2/13.9File #: 1.28**WELDING INSPECTION REPORT****Resident Engineer:** Siegenthaler, Peter**Address:** 333 Burma Road**City:** Oakland, CA 94607**Report No:** WIR-019819**Date Inspected:** 31-Jan-2011**Project Name:** SAS Superstructure**OSM Arrival Time:** 900**Prime Contractor:** American Bridge/Fluor Enterprises, a JV**OSM Departure Time:** 1730**Contractor:** American Bridge/Fluor Enterprises, a JV**Location:** Jobsite**CWI Name:** See below**CWI Present:** Yes No**Inspected CWI report:** Yes No N/A**Rod Oven in Use:** Yes No N/A**Electrode to specification:** Yes No N/A**Weld Procedures Followed:** Yes No N/A**Qualified Welders:** Yes No N/A**Verified Joint Fit-up:** Yes No N/A**Approved Drawings:** Yes No N/A**Approved WPS:** Yes No N/A**Delayed / Cancelled:** Yes No N/A**Bridge No:** 34-0006**Component:** SAS OBG**Summary of Items Observed:**

- 1). OBG Field Splice 9W/10W Weld ID: B1, Face B (SMAW)
- 2). OBG Field Welding of East Line Lifting Lug Hole Inserts (SMAW)
- 3). OBG Field Splice 9E/10E Weld ID: C1, Face A (FCAW-G)
- 4). OBG Field Splice 8W/9W Weld ID: F1, Face A – (SMAW R-1 Repairs)

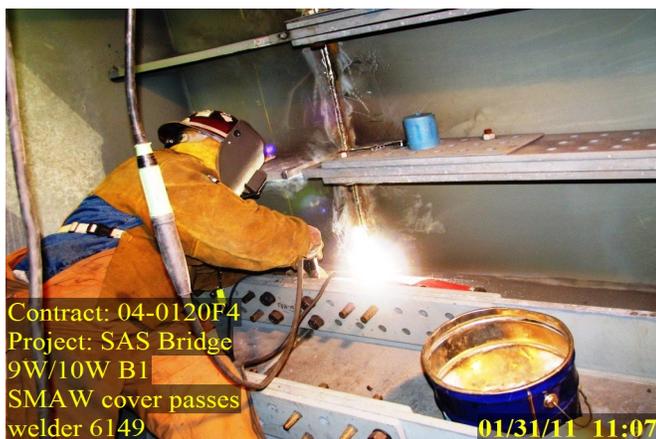
- 1). OBG Field Splice 9W/10W Weld ID: B1, Face B (SMAW)

The QAI periodically observed AB/F approved welder Jorge Lopez (ID 6149) performing welding of fill and cover passes on the interior of weld ID: B1 per the Shielded Metal Arc Welding (SMAW) process in the 3G (vertical) position. See photo below. The QAI observed QC Inspector Tony Sherwood was present to monitor the progress and verify that the welding parameters were within the limits established by the approved Welding Procedure Specification (WPS) identified as ABF-WPS-D1.5-1110A. The QAI observed that the work at this location was completed and appeared to be in general compliance with contract documents.

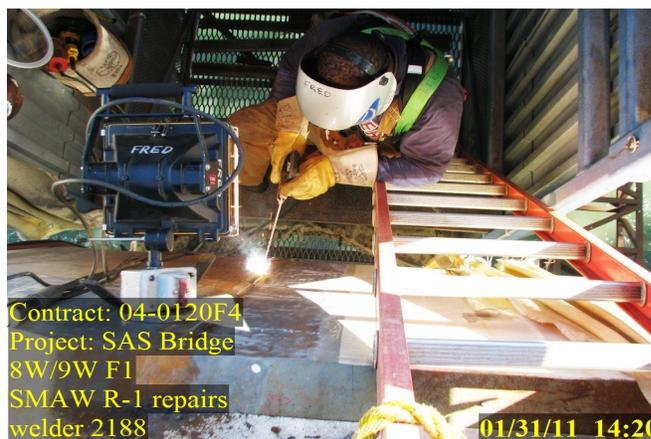
4). OBG Field Splice 8W/9W Weld ID: F1, Face A – (SMAW R-1 Repairs)

The QAI periodically observed AB/F approved welder Fred Kaddu (ID 2188) performing air carbon arc gouging and subsequent R-1 repair welding per the Shielded Metal Arc Welding (SMAW) process in the 3G (vertical) position on the exterior of OBG Field Splice 8W/9W Weld F1. The QAI randomly observed QC Inspector Jesse Cayabyab performing Magnetic Particle Testing (MT) of the excavated areas prior to repair welding. The QAI randomly observed that the performance and evaluation of the MT appeared to comply with the MT procedure identified as SE-MT-CT-D1.5-101 Rev. 4. The QAI randomly observed AB/F approved welder Fred Kaddu (ID 2188) performing repair welding of two excavated areas. See photo below. QC Inspector Jesse Cayabyab was present periodically to monitor the progress and verify that the repair welding parameters were within the limits established by the approved welding Procedure Specification (WPS) identified as ABF-WPS-D1.5-1001 Repair. The QAI observed that fill and cover pass welding of two excavations was in process during the QA Inspectors shift on this date and work at this location appeared to be in general compliance with contract documents. The QAI observed that the repair areas excavated on this date in weld F1 had the following dimensions and the following Y locations:

Y = 750mm, Length = 270mm, Depth = 12mm, Width = 25mm.

Y = 1020mm, Length = 120mm, Depth = 11mm, Width = 22mm.
