DEPARTMENT OF TRANSPORTATION

Quality Assurance and Source Inspection

Contract #: 04-0120F4Cty: SF/ALA Rte: 80 PM: 13.2/13.9File #: 69.28**WELDING INSPECTION REPORT****Resident Engineer:** Pursell, Gary**Address:** 333 Burma Road**City:** Oakland, CA 94607**Report No:** WIR-020029**Date Inspected:** 21-Apr-2010**Project Name:** SAS Superstructure**OSM Arrival Time:** 645**Prime Contractor:** American Bridge/Fluor Enterprises, a JV**OSM Departure Time:** 1845**Contractor:** Zhenhua Port Machinery Company, Ltd (ZPMC), Changxing Island **Location:** Shanghai, China

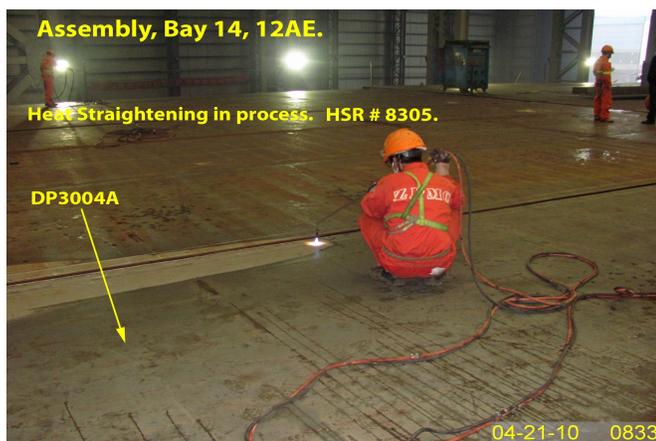
During Random Visual in process Inspection, this QA inspector observed ZPMC personnel Heat Straightening Deck Pannel DP3004A. ZPMC QC Li Ming Yang showed Heat Straightening Report HSR # 8305. The attached photographs provide additional detail.
