Quality Assurance and Source Inspection

Contract #: 04-0120F4Cty: SF/ALA Rte: 80 PM: 13.2/13.9File #: 69.28**WELDING INSPECTION REPORT****Resident Engineer:** Pursell, Gary**Address:** 333 Burma Road**City:** Oakland, CA 94607**Report No:** WIR-020068**Date Inspected:** 05-Mar-2010**Project Name:** SAS Superstructure**OSM Arrival Time:** 645**Prime Contractor:** American Bridge/Fluor Enterprises, a JV**OSM Departure Time:** 1845**Contractor:** Zhenhua Port Machinery Company, Ltd (ZPMC), Changxing Island **Location:** Shanghai, China**CWI Name:** Liu Hua Jie, Lu Li Qing.**CWI Present:** Yes No**Inspected CWI report:** Yes No N/A**Rod Oven in Use:** Yes No N/A**Electrode to specification:** Yes No N/A**Weld Procedures Followed:** Yes No N/A**Qualified Welders:** Yes No N/A**Verified Joint Fit-up:** Yes No N/A**Approved Drawings:** Yes No N/A**Approved WPS:** Yes No N/A**Delayed / Cancelled:** Yes No N/A**Bridge No:** 34-0006**Component:** Orthotropic Box Girder (OBG)**Summary of Items Observed:**

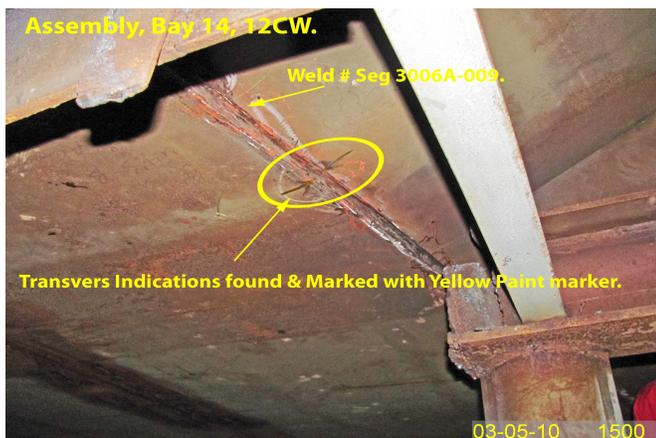
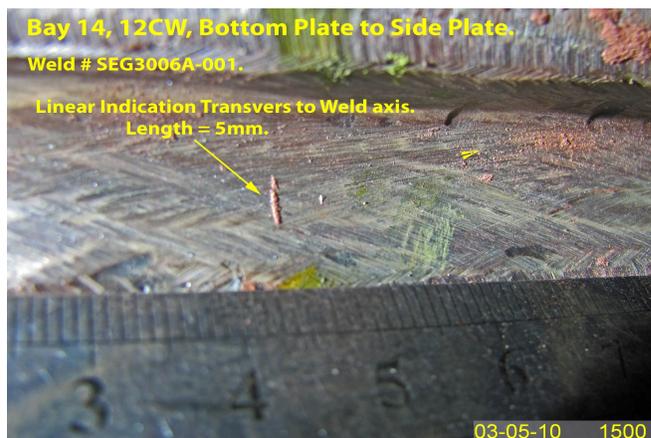
Assembly, Bay 14, 12CW, Base plate to Side plate.

During Random Magnetic Particle Testing (MT) in process Inspection after back gouging, this QA inspector observed following;

- Welds are identified as SEG3006A-001, 009, 011.
- This QA inspector observed five (5) linear indications transverse to the weld axis on four (4) different locations.
- Indications are marked with Yellow paint marker.
- This QA inspector also informed ZPMC QC & AB/F inspector about this.
- The attached photographs provide additional detail.
