**DEPARTMENT OF TRANSPORTATION**

Contract #: 04-0120F4Cty: SF/ALA Rte: 80 PM: 13.2/13.9File #: 1.28**WELDING INSPECTION REPORT****Resident Engineer:** Siegenthaler, Peter**Address:** 333 Burma Road**City:** Oakland, CA 94607**Report No:** WIR-020227**Date Inspected:** 01-Feb-2011**Project Name:** SAS Superstructure**OSM Arrival Time:** 900**Prime Contractor:** American Bridge/Fluor Enterprises, a JV**OSM Departure Time:** 1730**Contractor:** American Bridge/Fluor Enterprises, a JV**Location:** Jobsite**CWI Name:** See below**CWI Present:** Yes No**Inspected CWI report:** Yes No N/A**Rod Oven in Use:** Yes No N/A**Electrode to specification:** Yes No N/A**Weld Procedures Followed:** Yes No N/A**Qualified Welders:** Yes No N/A**Verified Joint Fit-up:** Yes No N/A**Approved Drawings:** Yes No N/A**Approved WPS:** Yes No N/A**Delayed / Cancelled:** Yes No N/A**Bridge No:** 34-0006**Component:** SAS OBG**Summary of Items Observed:**

## WELDING INSPECTION REPORT

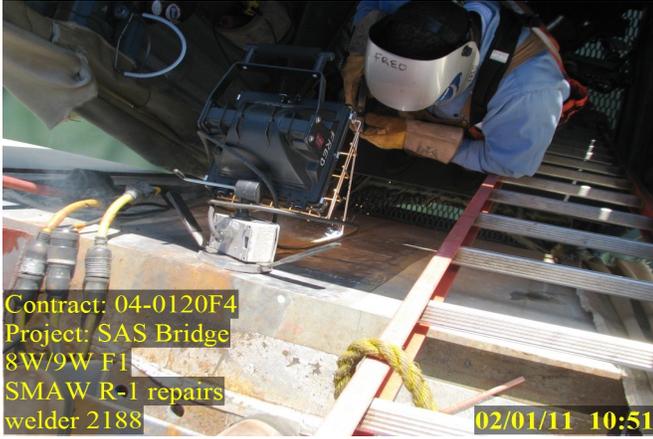
The QAI periodically observed AB/F approved welder Jorge Lopez (ID 6149) performing welding of root, fill and cover passes on the last 160mm of weld ID: A5 per the Shielded Metal Arc Welding (SMAW) process in the 1G (vertical) position. See photo below. The QAI observed QC Inspector Jesse Cayabyab was present to monitor the progress and verify that the welding parameters were within the limits established by the approved Welding Procedure Specification (WPS) identified as ABF-WPS-D1.5-1040A rev. 1. The QAI observed that the work at this location was complete and appeared to be in general compliance with contract documents.

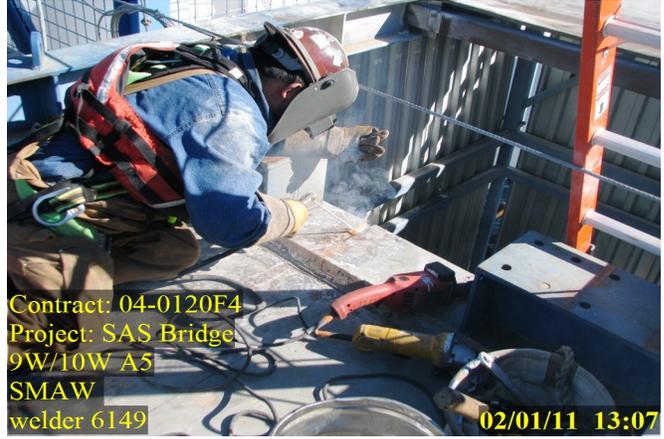
The QAI periodically observed AB/F approved welder Salvador Sandoval (ID 2202) performing welding of cover passes at OBG 6E PP44 E4 weld 2 per the Shielded Metal Arc Welding (SMAW) process in the 1G (flat) position.

QC Inspector Steve McConnell was periodically present to monitor the progress and verify that the welding parameters were within the limits established by the approved welding Procedure Specification (WPS) identified as ABF-WPS-D1.5-1070. Welding was completed at weld 2 and fit-up, root, fill and cover pass welding was completed at weld 4. Flush grinding was in process and the QAI observed that the work at this location appeared to be in general compliance with contract documents.
