Contract #: 04-0120F4Cty: SF/ALA Rte: 80 PM: 13.2/13.9File #: 69.28**WELDING INSPECTION REPORT****Resident Engineer:** Siegenthaler, Peter**Address:** 333 Burma Road**City:** Oakland, CA 94607**Report No:** WIR-020242**Date Inspected:** 29-Dec-2010**Project Name:** SAS Superstructure**OSM Arrival Time:** 700**Prime Contractor:** American Bridge/Fluor Enterprises, a JV**OSM Departure Time:** 1900**Contractor:** Zhenhua Port Machinery Company, Ltd (ZPMC), Changxing Island **Location:** Shanghai, China**CWI Name:** Mr. Zhu Zhong Hai.**CWI Present:** Yes No**Inspected CWI report:** Yes No N/A**Rod Oven in Use:** Yes No N/A**Electrode to specification:** Yes No N/A**Weld Procedures Followed:** Yes No N/A**Qualified Welders:** Yes No N/A**Verified Joint Fit-up:** Yes No N/A**Approved Drawings:** Yes No N/A**Approved WPS:** Yes No N/A**Delayed / Cancelled:** Yes No N/A**Bridge No:** 34-0006**Component:** Orthotropic Box Girder (OBG)**Summary of Items Observed:**

OBG TRAL ASSEMBLY

This QA Inspector performed randomly Visual Inspection and Ultrasonic Testing (UT) of approximately 10% of the area previously tested and accepted by ZPMC Quality Control personnel. This QA Inspector generated

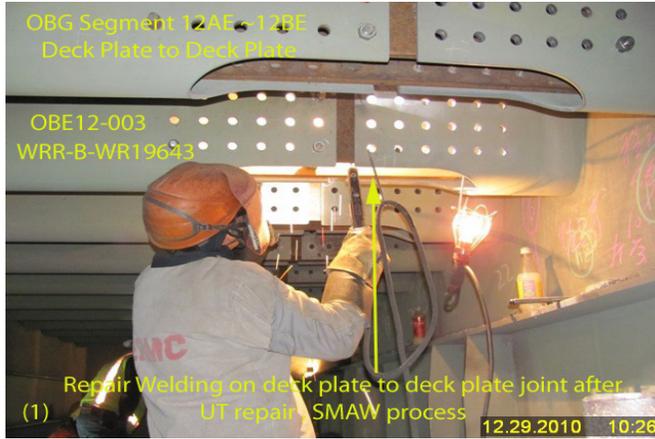
OBG Segment 12AE~12BE Repair Welding

This QA Inspector observed ZPMC qualified welding personnel identified as 044515, 050289 Perform Shielded Metal Arc Welding (SMAW) on OBG segment 12AE~12BE Deck plate to Deck plate joint from inside. ZPMC QC Identified as Wang Li Yang with Temporary welding repair report WRR-B-WR19643. The welding parameters as measured using QC's calibrated instrument appeared to be in general compliance with WPS-345-SMAW-4G (4F)-FCM-Repair-1. For more information see below attached picture number 1.

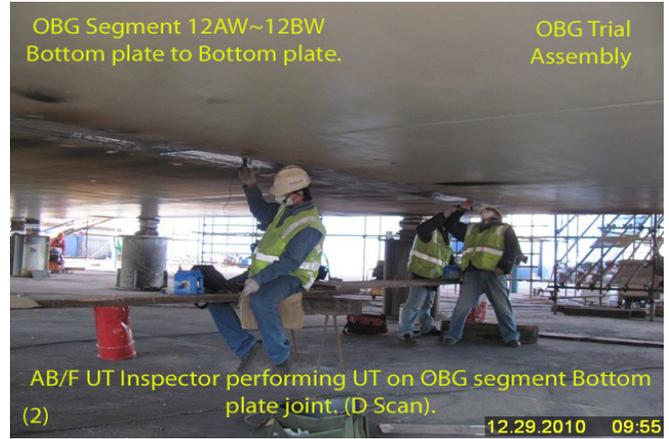
Ultrasonic Testing:

This QA Inspector observed AB/F Ultrasonic Testing Inspector, performed UT "D" scan on OBG Segment 12AW~12BW Bottom plate to Bottom plate joint. Joint identified as OBW12B-001. For more information see below attached picture number 2.
