Contract #: 04-0120F4Cty: SF/ALA Rte: 80 PM: 13.2/13.9File #: 1.28**WELDING INSPECTION REPORT****Resident Engineer:** Siegenthaler, Peter**Address:** 333 Burma Road**City:** Oakland, CA 94607**Report No:** WIR-020326**Date Inspected:** 03-Feb-2011**Project Name:** SAS Superstructure**OSM Arrival Time:** 900**Prime Contractor:** American Bridge/Fluor Enterprises, a JV**OSM Departure Time:** 1730**Contractor:** American Bridge/Fluor Enterprises, a JV**Location:** Job Site

WELDING INSPECTION REPORT

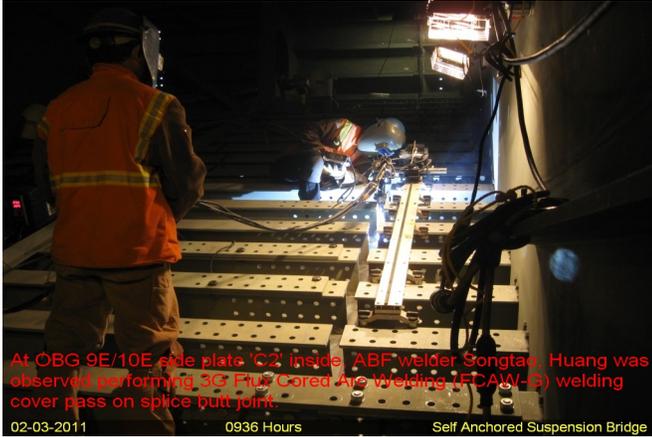
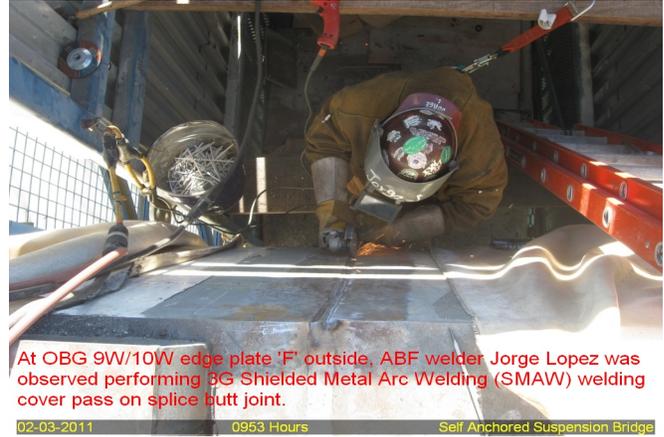
At OBG 9E/10E side plate 'C2' (5277mm to 7900mm) inside, QA randomly observed ABF/JV qualified welder Sungtao, Huang ID # 3794 continuing to perform CJP groove (splice) welding cover pass on the splice butt joint. The welder was observed perform automatic welding in the 3G (vertical) position utilizing a dual shield Flux Cored Arc Welding (FCAW-G) with E71T-1M, 1/16" diameter wire electrode and implementing Caltrans approved Welding Procedure Specification (WPS) ABF-WPS-D15-3042B-1. The joint being welded has a single V-groove butt joint with backing bar. The splice joint was preheated and maintained to greater than 150 degrees Fahrenheit using Miller Proheat 35 Induction Heating System heater blankets located at the opposite side of the plate prior/during welding. During welding, ABF Quality Control (QC) Fred Von Hoff was noted monitoring the welding parameters of the welder. During the shift, cover pass welding was completed at this location and the welder has moved to 'C2' 7900mm to 10555mm of the same OBG splice. While moving their welding equipment to the new location, ABF bolting personnel were noted removing the temporary WT stiffener connection plates which were blocking the access of the Bug-o track mounted nozzle holder.

QA randomly observed ABF/JV qualified welders Rory Hogan continuing to perform CJP groove (splice) back welding fill pass on Orthotropic Box Girder (OBG) 7W/8W bottom plate 'D2' outside. The welder was observed back welding fill pass in the 4G (overhead) position utilizing a dual shield Flux Cored Arc Welding (FCAW-G) with E71T-1M, 1/16" diameter wire electrode and implementing Caltrans approved Welding Procedure

At OBG 8W/9W edge plate 'B' inside, QA randomly observed ABF/JV qualified welder Fred Kaddu perform CJP repair welding. The welder was noted welding in 3G (vertical) position utilizing SMAW with 1/8" diameter E7018H4R electrode implementing Caltrans approved Welding Procedure Specification (WPS) ABF-WPS-D15-1001 Repairs. The welding repairs were excavated to a boat shape profile and were tested with MT prior welding. During welding, ABF QC William Sherwood was noted monitoring the welder and his welding parameters. QA noted parameter during welding was 130 amperes which appears in compliance to the WPS. The locations of the repairs were noted below;

At OBG 9W/10W edge plate 'F' outside, QA randomly observed ABF/JV qualified welder Jorge Lopez perform cover pass welding on the CJP splice butt joint. The welder was observed manually welding in the 3G (vertical) position utilizing a Shielded Metal Arc Welding (SMAW) with 1/8" diameter E7018H4R electrode and implementing Caltrans approved Welding Procedure Specification (WPS) ABF-WPS-D15-1040B. The joint being welded has a single V-groove butt joint with steel backing bar. During welding, ABF Quality Control (QC) William Sherwood was noted monitoring the welding parameters of the welder. QA randomly monitored the welding parameter with reading of 125 amperes which appears in conformance to the contract requirements. Before the end of the shift, SMAW cover pass welding was completed and the welder started flush grinding the weld cover reinforcement of the welded butt joint.

At OBG 6E-PP44-E4#1 to #4 lifting lug access hole to top deck plate inside - ABF welder Sal Sandoval was noted back gouging using carbon air arc gouging. After back gouging all four access holes, the welder started grinding the groove of the gouged holes. The grinding of the back gouged access holes and testing of the ground groove using MT was completed and the welder started welding. The welder was observed 4G SMAW back welding fill pass on the access hole #3. The welder was noted using 1/8" diameter E7018H4R electrode implementing Caltrans approved Welding Procedure Specification (WPS) ABF-WPS-D15-1110A. During welding, ABF QC Steve Mc Connell was noted monitoring the welder's welding parameters. At the end of shift, cover pass welding on this location was still continuing.
