Contract #: 04-0120F4Cty: SF/ALA Rte: 80 PM: 13.2/13.9File #: 69.28**WELDING INSPECTION REPORT****Resident Engineer:** Siegenthaler, Peter**Address:** 333 Burma Road**City:** Oakland, CA 94607**Report No:** WIR-020465**Date Inspected:** 09-Feb-2011**Project Name:** SAS Superstructure**OSM Arrival Time:** 700**Prime Contractor:** American Bridge/Fluor Enterprises, a JV**OSM Departure Time:** 1900**Contractor:** Zhenhua Port Machinery Company, Ltd (ZPMC), Changxing Island **Location:** Shanghai, China**CWI Name:** Qiu Wen**CWI Present:** Yes No**Inspected CWI report:** Yes No N/A**Rod Oven in Use:** Yes No N/A**Electrode to specification:** Yes No N/A**Weld Procedures Followed:** Yes No N/A**Qualified Welders:** Yes No N/A**Verified Joint Fit-up:** Yes No N/A**Approved Drawings:** Yes No N/A**Approved WPS:** Yes No N/A**Delayed / Cancelled:** Yes No N/A**Bridge No:** 34-0006**Component:** Orthotropic Box Girder (OBG)**Summary of Items Observed:**

WELDING INSPECTION REPORT

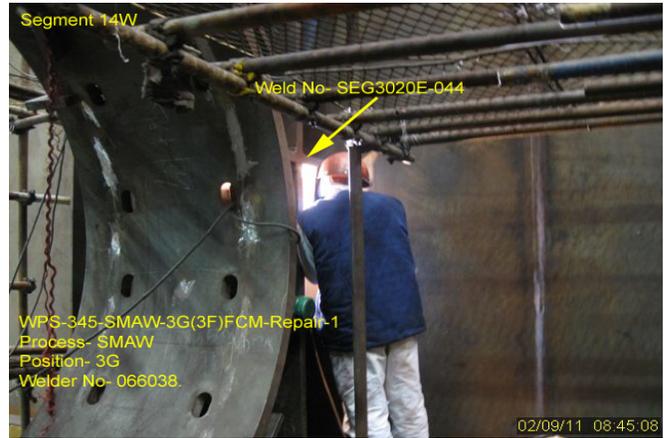
This QA Inspector observed ZPMC qualified welding personnel identified as 069683 perform Shielded Metal Arc Welding (SMAW), weld joint identified as SEG3020D-068; located On Orthotropic Box Girder (OBG) Floor Beam to Longitudinal Diaphragm CJP Weld; ABF Quality Assurance (QA) is identified as Mr. Yan Bao Jia. This QA Inspector observed a welding current of approximately 158 amps and 23.4 volts and the base material appears to have been being preheated by an electrical heating elements prior to welding. ABF Quality Assurance (QA) Mr. Yan Bao Jia was onsite monitoring the welding variables. The welding variables recorded by QA appeared to comply with applicable WPS-B-P-2214-TC-U4b-FCM-1. See attached photo for further details.
