**DEPARTMENT OF TRANSPORTATION**

Contract #: 04-0120F4Cty: SF/ALA Rte: 80 PM: 13.2/13.9File #: 1.28**WELDING INSPECTION REPORT****Resident Engineer:** Siegenthaler, Peter**Address:** 333 Burma Road**City:** Oakland, CA 94607**Report No:** WIR-020559**Date Inspected:** 11-Feb-2011**Project Name:** SAS Superstructure**OSM Arrival Time:** 800**Prime Contractor:** American Bridge/Fluor Enterprises, a JV**OSM Departure Time:** 1630**Contractor:** American Bridge/Fluor Enterprises, a JV**Location:** Job Site

## WELDING INSPECTION REPORT

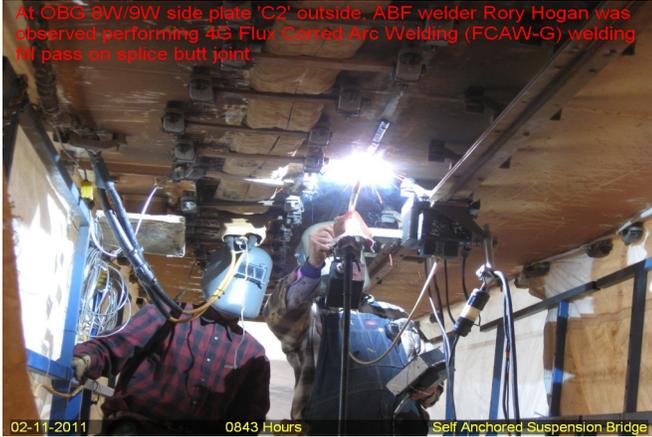
02-11-2011 0843 Hours Self Anchored Suspension Bridge

At OBG 8W/9W side plate 'C2' outside, ABF welder Rory Hogan was observed performing 4G Flux Cored Arc Welding (FCAW-G) welding fill pass on splice butt joint.

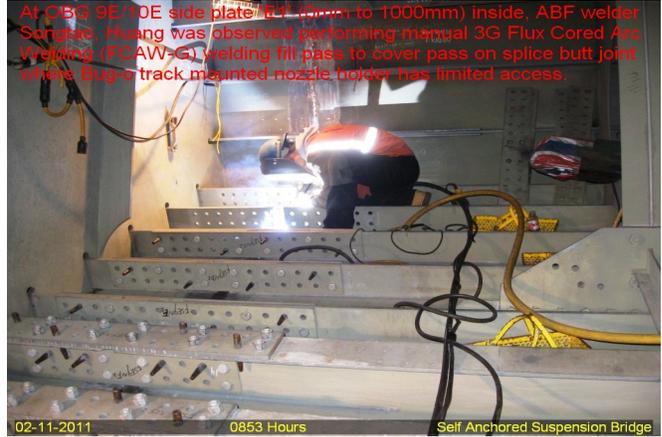
02-11-2011 0853 Hours Self Anchored Suspension Bridge

At OBG 9E/10E side plate 'RT' (50mm to 1000mm) inside, ABF welder Songtao Huang was observed performing manual 3G Flux Cored Arc Welding (FCAW-G) welding fill pass to cover pass on splice butt joint where bug-in track mounted nozzle holder has limited access.

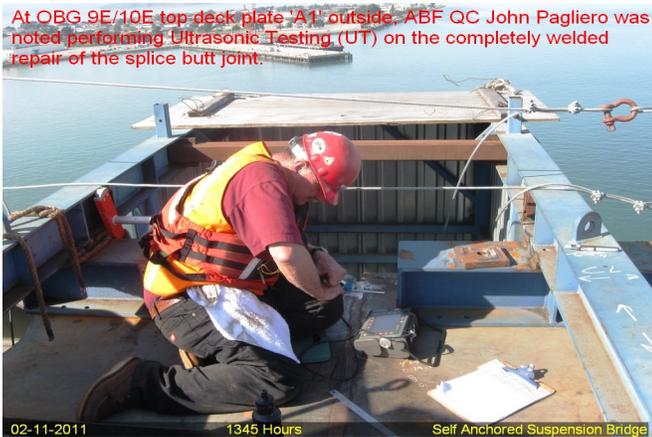
02-11-2011 1345 Hours Self Anchored Suspension Bridge

At OBG 9E/10E top deck plate 'A1' outside, ABF QC John Pagliero was noted performing Ultrasonic Testing (UT) on the completely welded repair of the splice butt joint.

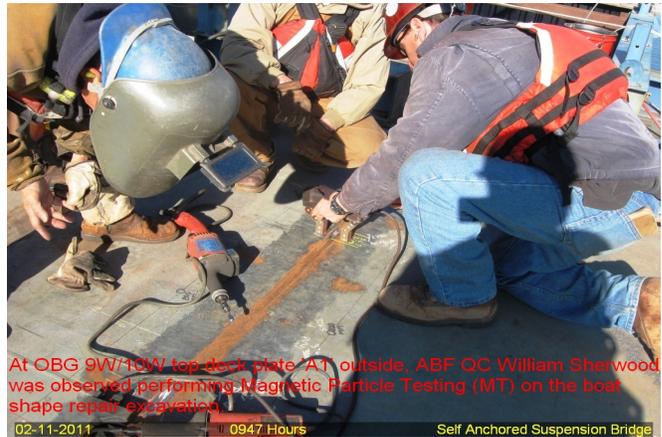
02-11-2011 0947 Hours Self Anchored Suspension Bridge

At OBG 9W/10W top deck plate 'A1' outside, ABF QC William Sherwood was observed performing Magnetic Particle Testing (MT) on the boat shape repair excavation.
