Contract #: 04-0120F4Cty: SF/ALA Rte: 80 PM: 13.2/13.9File #: 69.28**WELDING INSPECTION REPORT****Resident Engineer:** Siegenthaler, Peter**Address:** 333 Burma Road**City:** Oakland, CA 94607**Report No:** WIR-020615**Date Inspected:** 08-Dec-2010**Project Name:** SAS Superstructure**OSM Arrival Time:** 700**Prime Contractor:** American Bridge/Fluor Enterprises, a JV**OSM Departure Time:** 1900**Contractor:** Zhenhua Port Machinery Company, Ltd (ZPMC), Changxing Island **Location:** Shanghai, China

Bridge No: 34-0006**Component:** BAY 14 OBG**Summary of Items Observed:**

OBG BAY 14

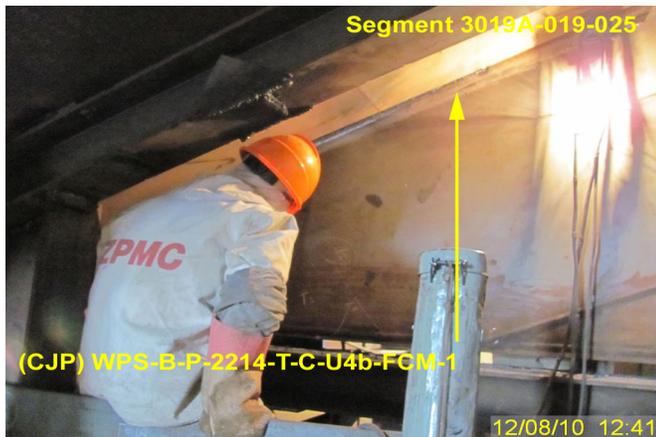
ZPMC personnel heat straightening Orthotropic Box Girder (OBG) member identified as Lift 13CE; VP3008A-001 weld joint(s) 032. Distortion appeared to be caused by welding of the material. ZPMC Quality Control (QC) inspector identified as Mr. Shao Jian Yuan was present to monitor the heat straightening process. The heat straightening appeared to comply with Heat Straightening Report HSR1 (B)-9831 (R787-QCP-1101) dated 11-11-2010.

SAW welding of complete joint penetration weld joint(s) located on Deck Plate identified as Segment 3020* DP3176 to 3177 weld number(s) 010. Welder is identified as welder no. 045265. The welding variables recorded by ZPMC QC identified as Mr. Shao Jian Yuan appeared to comply with applicable WPS(s) WPS-B-T-2221-B-L2C-S-2.

SMAW welding of complete joint penetration weld joint(s) located on Segment 3013AD Floor Beam to Side Panel weld number(s) 034. Welder is identified as welder no (s). 051348. The welding variables recorded by ZPMC QC identified as Sun Tian Liang appeared to comply with applicable WPS(s) WPS-B-P-2214-TC-U4b-FCM 1.

During random in process inspection of Orthotropic Box Girder (OBG) member identified as DP3104-001 weld number(s) 009 this QA Inspector observed weld repair of complete joint penetration weld joint(s). ZPMC Quality Control personnel previously tested and rejected sections of weld within weld no. 009. Weld joint consisted of SMAW welding of complete joint penetration weld joint(s). Welder is identified as welder no (s). 051359. The welding variables recorded by ZPMC QC identified as Zong Guo Hui appeared to comply with applicable WPS(s) WPS-345-SMAW-1G (1F)-FCM-Repair, WPS-345-4G (4F)-FCM-Repair and (WR18494).
