Contract #: 04-0120F4Cty: SF/ALA Rte: 80 PM: 13.2/13.9File #: 69.28**WELDING INSPECTION REPORT****Resident Engineer:** Siegenthaler, Peter**Address:** 333 Burma Road**City:** Oakland, CA 94607**Report No:** WIR-020811**Date Inspected:** 24-Oct-2010**Project Name:** SAS Superstructure**OSM Arrival Time:** 700**Prime Contractor:** American Bridge/Fluor Enterprises, a JV**OSM Departure Time:** 1900**Contractor:** Zhenhua Port Machinery Company, Ltd (ZPMC), Changxing Island **Location:** Shanghai, China**CWI Name:** Li Yan Hua**CWI Present:** Yes No**Inspected CWI report:** Yes No N/A**Rod Oven in Use:** Yes No N/A**Electrode to specification:** Yes No N/A**Weld Procedures Followed:** Yes No N/A**Qualified Welders:** Yes No N/A**Verified Joint Fit-up:** Yes No N/A**Approved Drawings:** Yes No N/A**Approved WPS:** Yes No N/A**Delayed / Cancelled:** Yes No N/A**Bridge No:** 34-0006**Component:** OBG Segment Assembly**Summary of Items Observed:**

OBG Segment 12AW

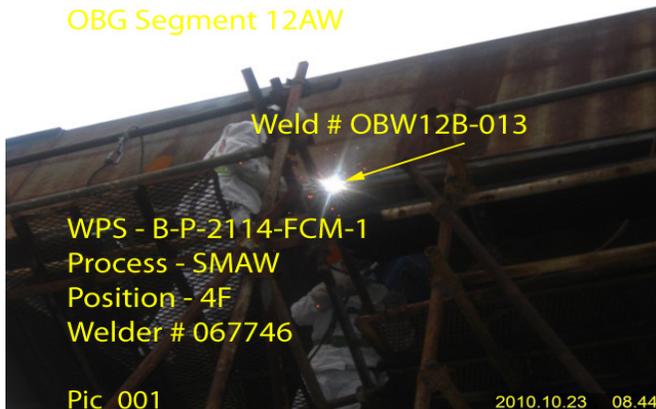
Shielded Metal Arc Welding (SMAW) in the 4F position of weld joint OBW12B-013 located on Counterweight side Drain Plate. The welder is identified as 067746. ZPMC Quality Control (QC) is identified as Wang Wei Ming.

The welding variables recorded by QC appeared to comply with the WPS B-P-2114-FCM-1. See attached photograph Pic_001.
