**DEPARTMENT OF TRANSPORTATION**

Contract #: 04-0120F4Cty: SF/ALA Rte: 80 PM: 13.2/13.9File #: 1.28**WELDING INSPECTION REPORT****Resident Engineer:** Siegenthaler, Peter**Address:** 333 Burma Road**City:** Oakland, CA 94607**Report No:** WIR-020899**Date Inspected:** 18-Feb-2011**Project Name:** SAS Superstructure**OSM Arrival Time:** 800**Prime Contractor:** American Bridge/Fluor Enterprises, a JV**OSM Departure Time:** 1630**Contractor:** American Bridge/Fluor Enterprises, a JV**Location:** Job Site

# WELDING INSPECTION REPORT

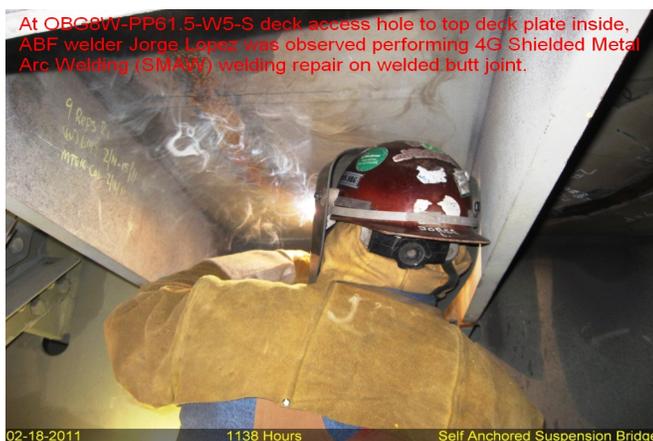
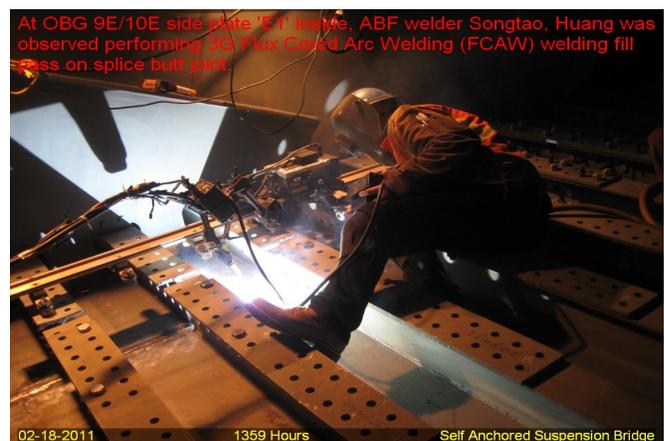
At OBG 9E/10E side plate 'E2' (2638mm to 5278mm ) inside, QA randomly observed ABF/JV qualified welder Sungtao, Huang ID # 3794 perform CJP groove (splice) welding fill pass cover pass on the splice butt joint. The welder was observed perform automatic welding in the 3G (vertical) position utilizing a dual shield Flux Cored Arc Welding (FCAW-G) with E71T-1M, 1/16" diameter wire electrode and implementing Caltrans approved Welding Procedure Specification (WPS) ABF-WPS-D15-3042B-1. The joint being welded has a single V-groove butt joint with backing bar. The splice joint was preheated and maintained to greater than 150 degrees Fahrenheit using Miller Proheat 35 Induction Heating System heater blankets located at the opposite side of the plate prior/during welding. During welding, ABF Quality Control (QC) Steve Jensen was noted monitoring the welding parameters of the welder. At the end of the shift, cover pass welding was still continuing and should remain Monday.

QA randomly observed ABF/JV qualified welders Rory Hogan continuing to perform CJP groove (splice) back welding fill pass on Orthotropic Box Girder (OBG) 8W/9W side plate 'D2' outside. The welder was observed back welding in the 4G (overhead) position utilizing a dual shield Flux Cored Arc Welding (FCAW-G) with E71T-1M, 1/16" diameter wire electrode and implementing Caltrans approved Welding Procedure Specification (WPS) ABF-WPS-D15-3110-4. The welder was using a track mounted welder holder assembly that was remotely controlled. The joint being welded has the backing bar gouged using the Esab Plasma Arc machine and was

At OBG 8W-PP61.5-W5-SW deck access hole to top deck plate inside, QA randomly observed ABF/JV qualified welder Jorge Lopez perform CJP repair welding. The welder was noted welding in 4G (overhead) position utilizing SMAW with 1/8" diameter E7018H4R electrode implementing new Caltrans approved Welding Procedure Specification (WPS) ABF-WPS-D15-1001 Repair. The second time welding repair located at Y=820mm and having dimensions of 100mm long x 30mm wide x 12mm deep was excavated to a boat shape profile and was tested with Magnetic Particle Testing (MT) prior welding. During welding, ABF QC William Sherwood was noted monitoring the welder and his welding parameters. QA noted parameter during welding was 130 amperes which appears in compliance to the WPS. At the end of the shift, welding repair at this location was completed.
