Quality Assurance and Source Inspection

Contract #: 04-0120F4Cty: SF/ALA Rte: 80 PM: 13.2/13.9File #: 82.28**WELDING INSPECTION REPORT****Resident Engineer:** Siegenthaler, Peter**Address:** 333 Burma Road**City:** Oakland, CA 94607**Report No:** WIR-020957**Date Inspected:** 10-Feb-2011**Project Name:** SAS Superstructure**OSM Arrival Time:** 700**Prime Contractor:** American Bridge/Fluor Enterprises, a JV**OSM Departure Time:** 1530**Contractor:** Westmont Industries**Location:** Santa Fe Springs, CA.**CWI Name:** Ruben Dominguez**CWI Present:** Yes No**Inspected CWI report:** Yes No N/A**Rod Oven in Use:** Yes No N/A**Electrode to specification:** Yes No N/A**Weld Procedures Followed:** Yes No N/A**Qualified Welders:** Yes No N/A**Verified Joint Fit-up:** Yes No N/A**Approved Drawings:** Yes No N/A**Approved WPS:** Yes No N/A**Delayed / Cancelled:** Yes No N/A**Bridge No:** 34-0006**Component:** Travelers**Summary of Items Observed:**

E2/E3-EB Traveler-South

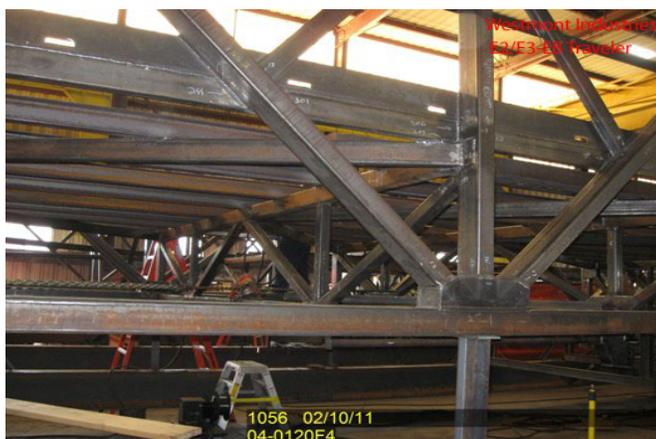
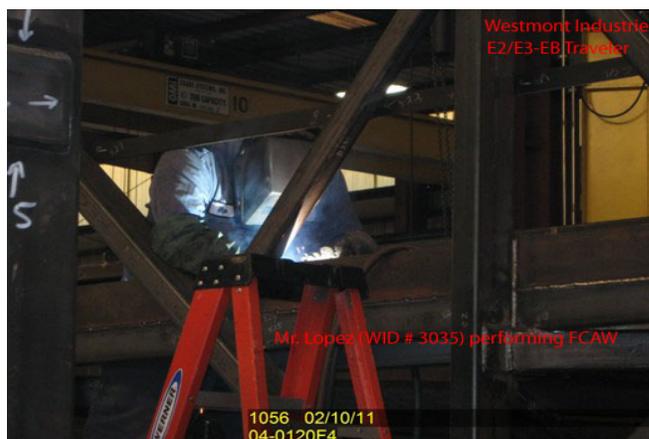
This QA Inspector observed WMI production welder Mr. Jose Rodriguez (WID # 3031) continuing to perform Flux Core Arc Welding (FCAW) in various positions on Tube Steel (TS) and connector plate material. This QA Inspector observed that the FCAW was being performed on the frame assemblies identified as A316, A324, A325, A332 and B332, South Side section of the E2/E3-EB Traveler. Additionally, this QA Inspector observed WMI production welder Mr. Jim Muetzel (WID # 3133) performing Flux Core Arc Welding (FCAW) activities on the above mentioned assemblies. This QA Inspector observed Mr. Muetzel performing the FCAW in all positions, throughout the shift. Additionally, this QA Inspector observed WMI production welder Mr. Eutimo Lopez (WID # 3035) performing Flux Core Arc Welding (FCAW) activities on the above mentioned assemblies. This QA Inspector observed Mr. Lopez performing the FCAW in all positions, throughout the shift. See attached pictures below.

This QA Inspector observed that the activities mentioned above, appeared to be in compliance with the contract requirements and this QA Inspector observed no non-conforming issues, on this date.
