DEPARTMENT OF TRANSPORTATION

Contract #: 04-0120F4Cty: SF/ALA Rte: 80 PM: 13.2/13.9File #: 69.28**WELDING INSPECTION REPORT****Resident Engineer:** Siegenthaler, Peter**Address:** 333 Burma Road**City:** Oakland, CA 94607**Report No:** WIR-020973**Date Inspected:** 03-Feb-2011**Project Name:** SAS Superstructure**OSM Arrival Time:** 700**Prime Contractor:** American Bridge/Fluor Enterprises, a JV**OSM Departure Time:** 1500**Contractor:** Zhenhua Port Machinery Company, Ltd (ZPMC), Changxing Island **Location:** Shanghai, China**CWI Name:** Li yang**CWI Present:** Yes No**Inspected CWI report:** Yes No N/A**Rod Oven in Use:** Yes No N/A**Electrode to specification:** Yes No N/A**Weld Procedures Followed:** Yes No N/A**Qualified Welders:** Yes No N/A**Verified Joint Fit-up:** Yes No N/A**Approved Drawings:** Yes No N/A**Approved WPS:** Yes No N/A**Delayed / Cancelled:** Yes No N/A**Bridge No:** 34-0006**Component:** Orthotropic Box Girder (OBG)**Summary of Items Observed:**

OBG # CROSSBEAM CB17

OBG # CROSSBEAM CB19

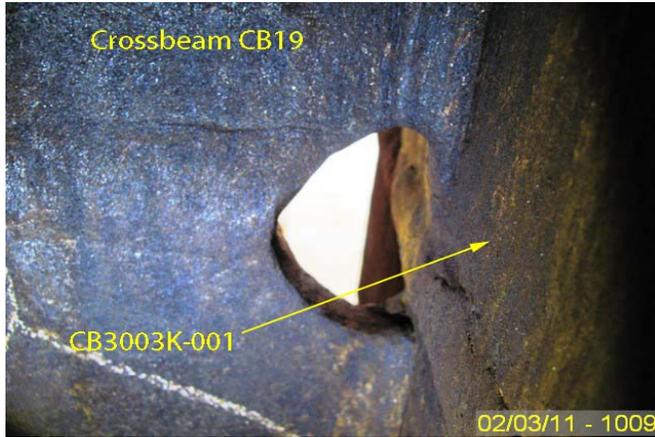
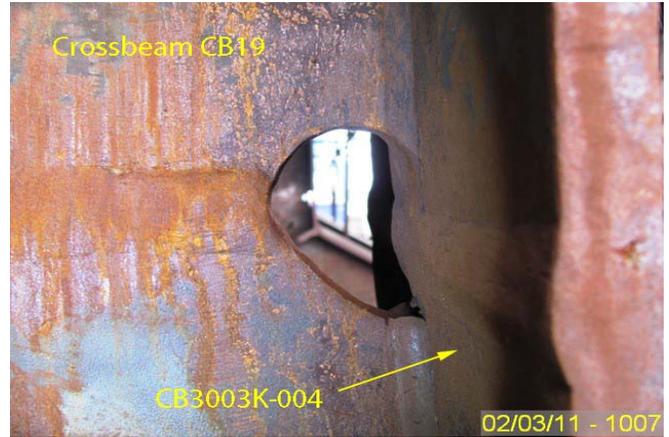
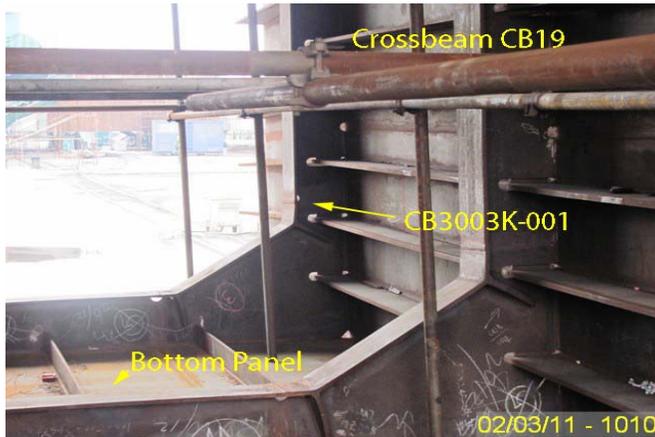
This QA inspector performed random visual inspection of this crossbeam this QA observed several cope holes in the floor beam diaphragms and that do not appear to comply with the contract documents. Fabrication of this crossbeam is still in process and has not yet been released to QA for final inspection. This QA marked the areas in question for the contractors QC to inspect and evaluate. See attached photos.
