DEPARTMENT OF TRANSPORTATION

Quality Assurance and Source Inspection

Contract #: 04-0120F4Cty: SF/ALA Rte: 80 PM: 13.2/13.9File #: 69.28**WELDING INSPECTION REPORT****Resident Engineer:** Siegenthaler, Peter**Address:** 333 Burma Road**City:** Oakland, CA 94607**Report No:** WIR-020993**Date Inspected:** 21-Feb-2011**Project Name:** SAS Superstructure**OSM Arrival Time:** 1900**Prime Contractor:** American Bridge/Fluor Enterprises, a JV**OSM Departure Time:** 700**Contractor:** Zhenhua Port Machinery Company, Ltd (ZPMC), Changxing Island **Location:** Shanghai China**CWI Name:** See below**CWI Present:** Yes No**Inspected CWI report:** Yes No N/A**Rod Oven in Use:** Yes No N/A**Electrode to specification:** Yes No N/A**Weld Procedures Followed:** Yes No N/A**Qualified Welders:** Yes No N/A**Verified Joint Fit-up:** Yes No N/A**Approved Drawings:** Yes No N/A**Approved WPS:** Yes No N/A**Delayed / Cancelled:** Yes No N/A**Bridge No:** 34-0006**Component:** OBG**Summary of Items Observed:**

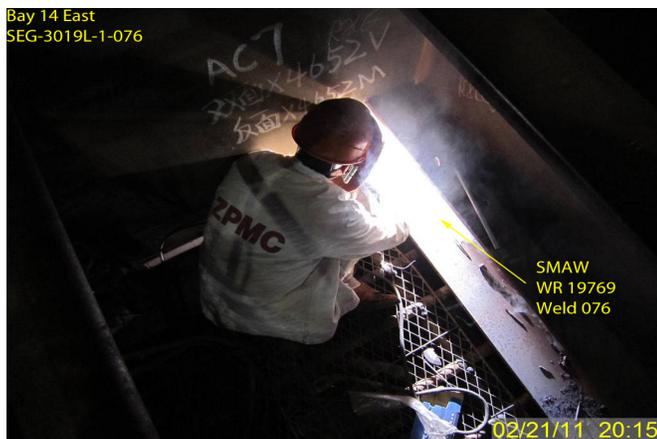
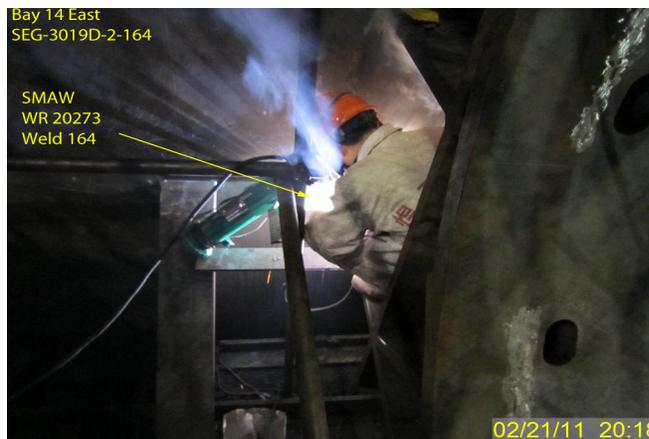
Unless otherwise noted, all work observed on this date appeared to be in general compliance with the applicable contract documents.
