Contract #: 04-0120F4Cty: SF/ALA Rte: 80 PM: 13.2/13.9File #: 69.28**WELDING INSPECTION REPORT****Resident Engineer:** Siegenthaler, Peter**Address:** 333 Burma Road**City:** Oakland, CA 94607**Report No:** WIR-021267**Date Inspected:** 01-Jul-2010**Project Name:** SAS Superstructure**OSM Arrival Time:** 700**Prime Contractor:** American Bridge/Fluor Enterprises, a JV**OSM Departure Time:** 1900**Contractor:** Zhenhua Port Machinery Company, Ltd (ZPMC), Changxing Island **Location:** Shanghai, China**CWI Name:** Li Yan Hua**CWI Present:** Yes No**Inspected CWI report:** Yes No N/A**Rod Oven in Use:** Yes No N/A**Electrode to specification:** Yes No N/A**Weld Procedures Followed:** Yes No N/A**Qualified Welders:** Yes No N/A**Verified Joint Fit-up:** Yes No N/A**Approved Drawings:** Yes No N/A**Approved WPS:** Yes No N/A**Delayed / Cancelled:** Yes No N/A**Bridge No:** 34-0006**Component:** OBG Segment Assembly**Summary of Items Observed:**

**OBG Segment 9BE-9CE**

# WELDING INSPECTION REPORT

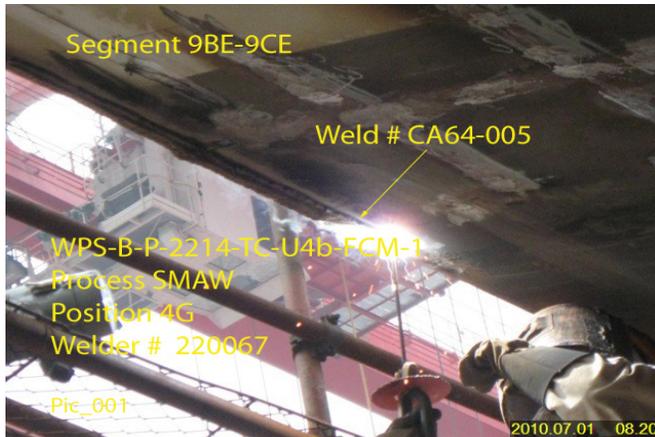
Shielded Metal Arc Welding (SMAW) in the 4G position of Bike Path side EP to SP holdback area, weld joint CA64-005. The welder is identified as 220067. ZPMC CWI is identified as Anqing Xiang. The welding variables recorded by QC appeared to comply with WPS-B-P-2214-TC-U4b-FCM-1. See attached photograph Pic\_001

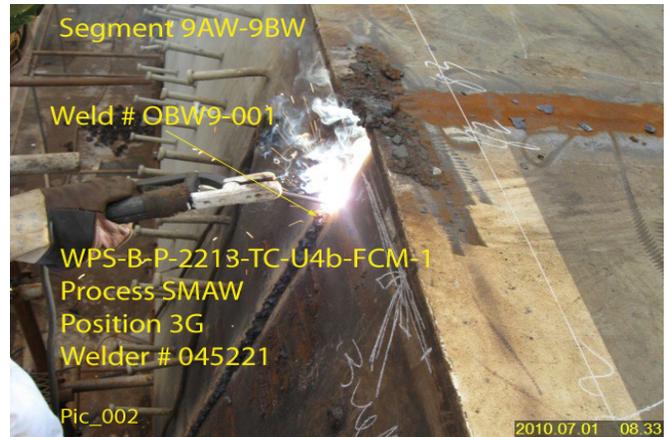
**OBG Segment 9AW-9BW**

Shielded Metal Arc Welding (SMAW) in the 3G position of Counterweight side Edge Panel, weld joint OBW9-001. The welder is identified as 045221. ZPMC Quality Control (QC) is identified as Zhang Hai Tao. The welding variables recorded by QC appeared to comply with WPS-B-P-2213-TC-U4b-FCM-1. See attached photograph Pic\_002
