Contract #: 04-0120F4Cty: SF/ALA Rte: 80 PM: 13.2/13.9File #: 99.28**WELDING INSPECTION REPORT****Resident Engineer:** Siegenthaler, Peter**Address:** 333 Burma Road**City:** Oakland, CA 94607**Report No:** WIR-021301**Date Inspected:** 03-Mar-2011**Project Name:** SAS Superstructure**OSM Arrival Time:** 700**Prime Contractor:** American Bridge/Fluor Enterprises, a JV**OSM Departure Time:** 1900**Contractor:** Zhenhua Port Machinery Company, Ltd (ZPMC) Chanxing Island **Location:** Shanghai, China**CWI Name:** Mr. ZHU ZHONG HAI**CWI Present:** Yes No**Inspected CWI report:** Yes No N/A**Rod Oven in Use:** Yes No N/A**Electrode to specification:** Yes No N/A**Weld Procedures Followed:** Yes No N/A**Qualified Welders:** Yes No N/A**Verified Joint Fit-up:** Yes No N/A**Approved Drawings:** Yes No N/A**Approved WPS:** Yes No N/A**Delayed / Cancelled:** Yes No N/A**Bridge No:** 34-0006**Component:** OBG Segment**Summary of Items Observed:**

WELDING INSPECTION REPORT

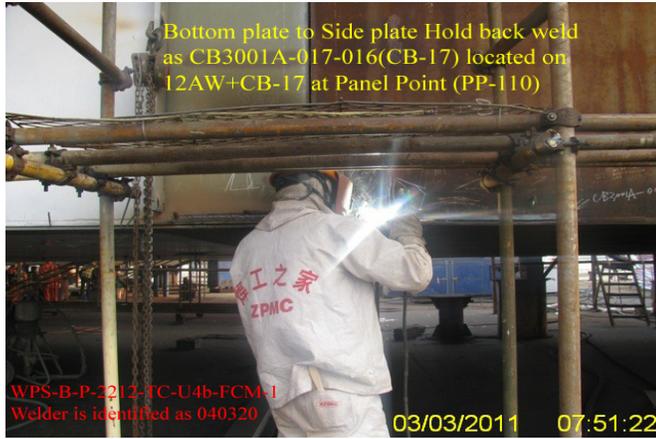
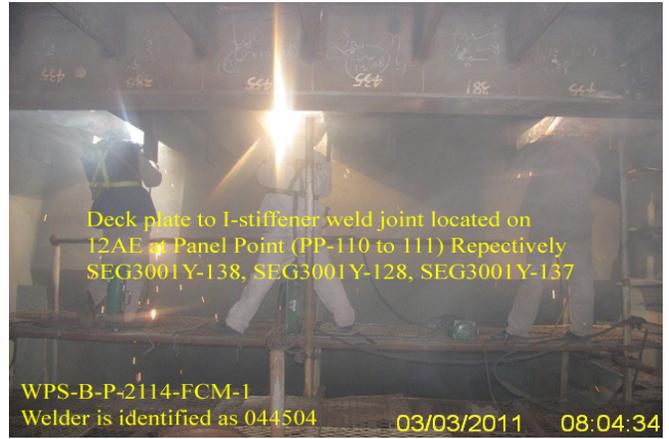
ZPMC welding personnel performing Shielded Metal Arc Welding of Complete Joint Penetration welds joining the bottom plate to side plate hold back weld joint located on 12AW+CB-17 at Panel Point (PP-110). The weld is designated as CB3001A-017-016(CB-17). The welder is identified as 040320. ZPMC QC Mr. LI YANG was onsite monitoring the welding variables. The inprocess Shielded Metal Arc Welding appears to be progressing in compliance with WPS-B-P-2212-TC-U4b-FCM-1. Further weld detail mention in attached picture.

ZPMC welding personnel performing Shielded Metal Arc Welding of Fillet welds joining the deck plate to I-stiffener weld joint located on 12AE at Panel Point (PP-110 to 111). The weld is designated as SEG3001Y-138. The welder is identified as 040270. ZPMC QC Mr. LI YANG was onsite monitoring the welding variables. The

inprocess Shielded Metal Arc Welding appears to be progressing in compliance with WPS-B-P-2114-FCM-1. Further weld detail mention in attached picture.

ZPMC welding personnel performing Shielded Metal Arc Welding of Fillet welds joining the deck plate to I-stiffener weld joint located on 12AE at Panel Point (PP-110 to 111). The weld is designated as SEG3001Y-128. The welder is identified as 044504. ZPMC QC Mr. LI YANG was onsite monitoring the welding variables. The inprocess Shielded Metal Arc Welding appears to be progressing in compliance with WPS-B-P-2114-FCM-1. Further weld detail mention in attached picture.

ZPMC welding personnel performing Shielded Metal Arc Welding of Fillet welds joining the deck plate to I-stiffener weld joint located on 12AE at Panel Point (PP-110 to 111). The weld is designated as SEG3001Y-137. The welder is identified as 068764. ZPMC QC Mr. LI YANG was onsite monitoring the welding variables. The inprocess Shielded Metal Arc Welding appears to be progressing in compliance with WPS-B-P-2114-FCM-1. Further weld detail mention in attached picture.
