**DEPARTMENT OF TRANSPORTATION**

Contract #: 04-0120F4Cty: SF/ALA Rte: 80 PM: 13.2/13.9File #: 69.28**WELDING INSPECTION REPORT****Resident Engineer:** Siegenthaler, Peter**Address:** 333 Burma Road**City:** Oakland, CA 94607**Report No:** WIR-021537**Date Inspected:** 06-Mar-2011**Project Name:** SAS Superstructure**OSM Arrival Time:** 700**Prime Contractor:** American Bridge/Fluor Enterprises, a JV**OSM Departure Time:** 1900**Contractor:** Zhenhua Port Machinery Company, Ltd (ZPMC), Changxing Island **Location:** Shanghai, China**CWI Name:** Xu tao**CWI Present:** Yes No**Inspected CWI report:** Yes No N/A**Rod Oven in Use:** Yes No N/A**Electrode to specification:** Yes No N/A**Weld Procedures Followed:** Yes No N/A**Qualified Welders:** Yes No N/A**Verified Joint Fit-up:** Yes No N/A**Approved Drawings:** Yes No N/A**Approved WPS:** Yes No N/A**Delayed / Cancelled:** Yes No N/A**Bridge No:** 34-0006**Component:** OBG Components**Summary of Items Observed:**

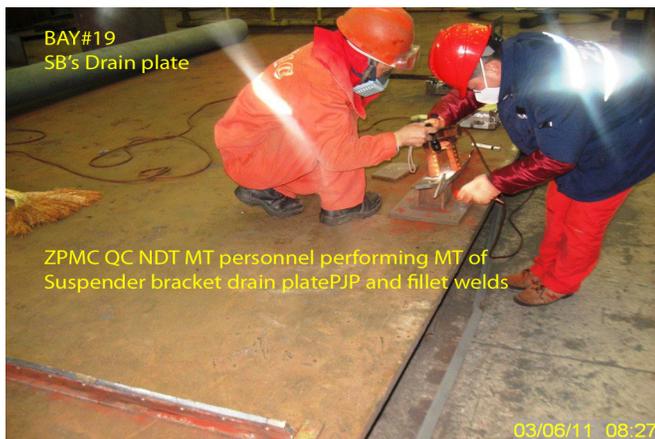
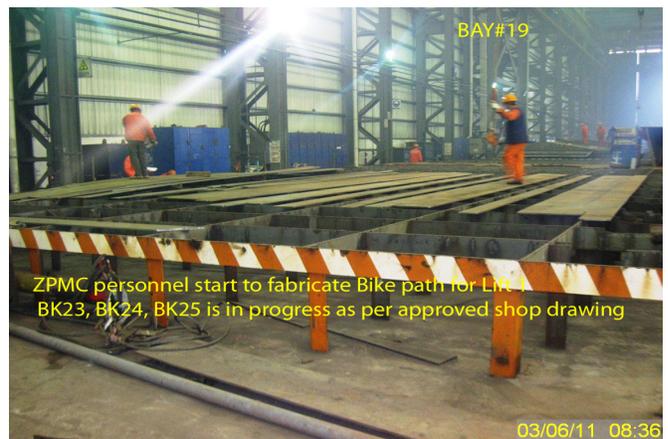
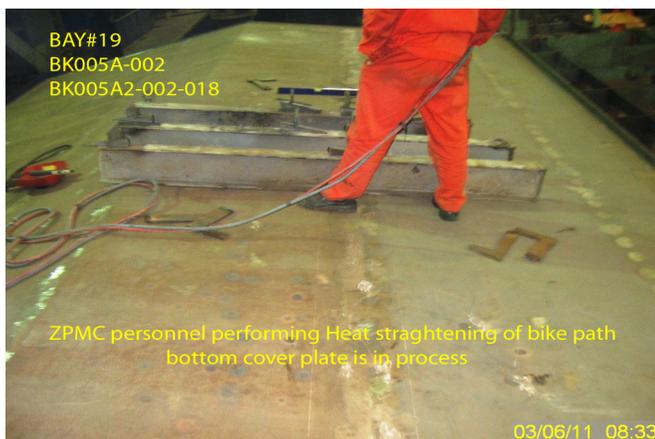
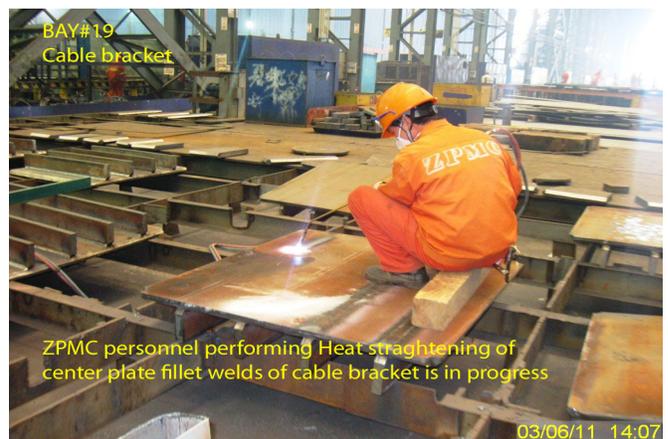
SMAW welding of VT repair welding is in progress of Suspender bracket drain plate is identified as SBDP-P3-072,073. The welder is identified as 0259566. ZPMC QC is identified as Mr.Guo xing hui. The welding variables recorded by QC are appeared to comply with the WPS-B-P-2112.

ZPMC personnel performing grinding of Cable bracket fillet welds which is connecting centre plate to stiffener plate is identified as SA6031, SA 6530.

ZPMC personnel performing heat straightening of Cable bracket fillet welds which is connecting centre plate to stiffener plate is identified as SA6029, SA 6030 as per approved HSR1 (B)-10157.

ZPMC QC NDT MT personnel performing Magnetic particle testing of PJP and fillet welds of Suspender bracket drain plate is in progress.

ZPMC personnel performing Heat straightening of Bike path is identified as BK004B-001 bottom cover plate is in progress as per approved HSR1 (B)-9501.

ZPMC personnel performing Heat straightening of Bike path is identified as BK004A-013 bottom cover plate is in

progress as per approved HSR1 (B)-9501.

ZPMC personnel received material for Bike path for Lift 1 is identified as BK23, BK24, and BK25 start to fabricate stringer plate is in progress as per approved drawings.

ZPMC QC NDT MT personnel performing magnetic particle of bike path bottom cover plate plug welds in progress of BK005A-002 during their MT they found Linear indications, this is informed to ZPMC QC Mr.Xu tao to make CWR before go for repair.
