Contract #: 04-0120F4Cty: SF/ALA Rte: 80 PM: 13.2/13.9File #: 69.28**WELDING INSPECTION REPORT****Resident Engineer:** Siegenthaler, Peter**Address:** 333 Burma Road**City:** Oakland, CA 94607**Report No:** WIR-021575**Date Inspected:** 31-Jan-2011**Project Name:** SAS Superstructure**OSM Arrival Time:** 700**Prime Contractor:** American Bridge/Fluor Enterprises, a JV**OSM Departure Time:** 1900**Contractor:** Zhenhua Port Machinery Company, Ltd (ZPMC), Changxing Island **Location:** Shanghai, China**CWI Name:** Mr. Xu Le Feng.**CWI Present:** Yes No**Inspected CWI report:** Yes No N/A**Rod Oven in Use:** Yes No N/A**Electrode to specification:** Yes No N/A**Weld Procedures Followed:** Yes No N/A**Qualified Welders:** Yes No N/A**Verified Joint Fit-up:** Yes No N/A**Approved Drawings:** Yes No N/A**Approved WPS:** Yes No N/A**Delayed / Cancelled:** Yes No N/A**Bridge No:** 34-0006**Component:** Tower and Orthotropic Box Girder (OBG)**Summary of Items Observed:**

WELDING INSPECTION REPORT

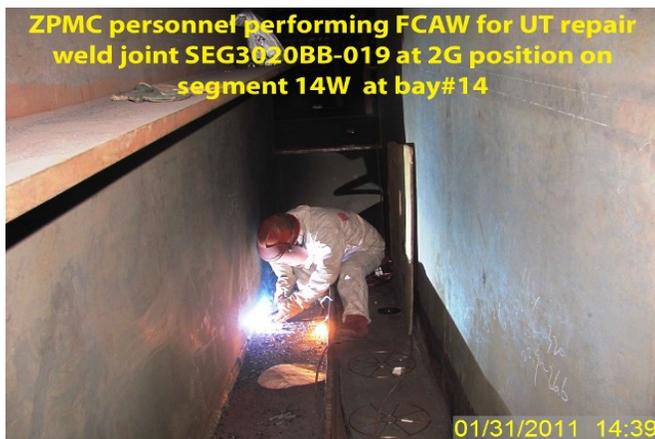
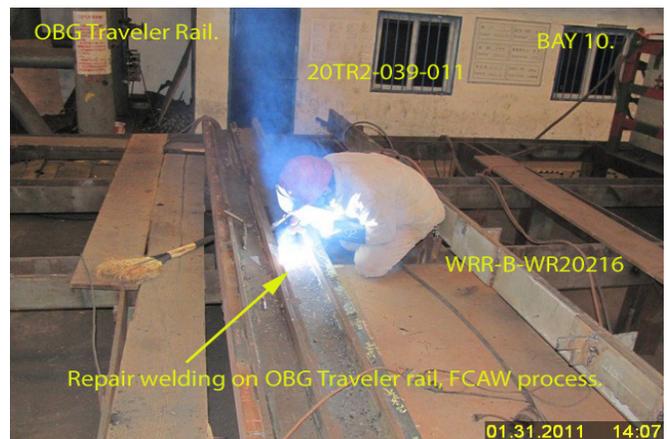
Bay 14, Segment 14W

SMAW in the 2G position for the OBG Segment 14W, UT repair weld No. SEG3020D-052. The welder is identified as #066398. ABF QC is identified as Mr. Wang Xiang Ping. The welding variables recorded by QC appear to comply with WPS-345-SMAW-2G (2F)-FCM-REPAIR-1. The weld repair report is identified as CWR2734. The welding variables were recorded. The In-process SMAW appears to be progressing in compliance with approved contract documents.

SMAW in the 3G position for the OBG Segment 14W, UT repair weld No.SEG3020Y-022. The welder is identified as #045246. ZPMC QC is identified as Mr. Xiao Jun Peng. The welding variables recorded by QC appear to comply with WPS-345-SMAW-3G (3F)-FCM-REPAIR-1. The weld repair report is identified as CWR2792. The welding variables were recorded. The In-process SMAW appears to be progressing in compliance with approved contract documents.

FCAW in the 2G position for the OBG Segment 14W, weld No.DP3169-001-262. The welder is identified as #066239. ABF QC is identified as Mr. Shao Jian Yuan. The welding variables recorded by QC appear to comply with WPS-B-T-2232-ESAB. The welding variables were recorded. The In-process FCAW appears to be progressing in compliance with approved contract documents.

FCAW in the 2G position for the OBG Segment 14W, UT repair weld No.SEG3020BB-019. The welder is identified as #066421. ABF QC is identified as Mr. Wang Xiang Ping. The welding variables recorded by QC appear to comply with WPS-345-FCAW-2G (2F)-FCM-REPAIR-1. The weld repair report is identified as CWR2752. The welding variables were recorded at. The In-process FCAW appears to be progressing in compliance with approved contract documents.
