DEPARTMENT OF TRANSPORTATION

Quality Assurance and Source Inspection

Contract #: 04-0120F4Cty: SF/ALA Rte: 80 PM: 13.2/13.9File #: 69.28**WELDING INSPECTION REPORT****Resident Engineer:** Siegenthaler, Peter**Address:** 333 Burma Road**City:** Oakland, CA 94607**Report No:** WIR-021658**Date Inspected:** 09-Mar-2011**Project Name:** SAS Superstructure**OSM Arrival Time:** 700**Prime Contractor:** American Bridge/Fluor Enterprises, a JV**OSM Departure Time:** 1900**Contractor:** Zhenhua Port Machinery Company, Ltd (ZPMC), Changxing Island **Location:** Shanghai, China

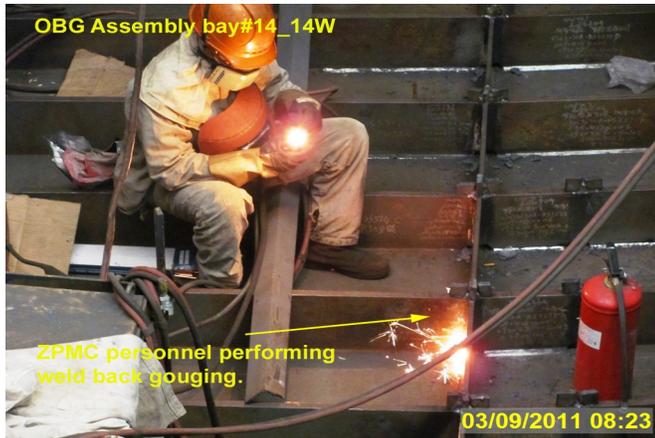
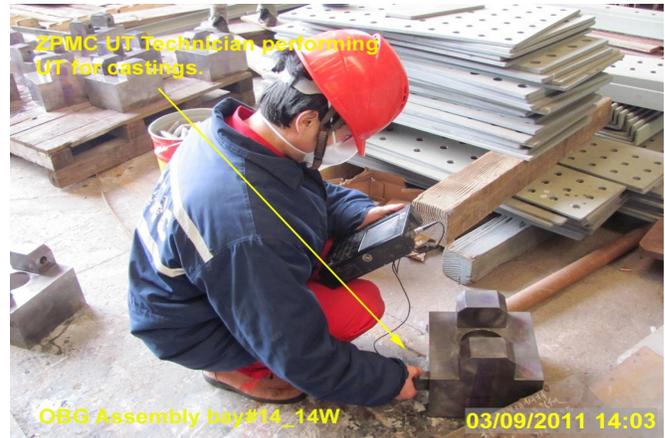
ZPMC personnel performing weld back gouging for the I rib stiffener plate weld joints located at panel point no 126.5. Refer the attached photos for reference.

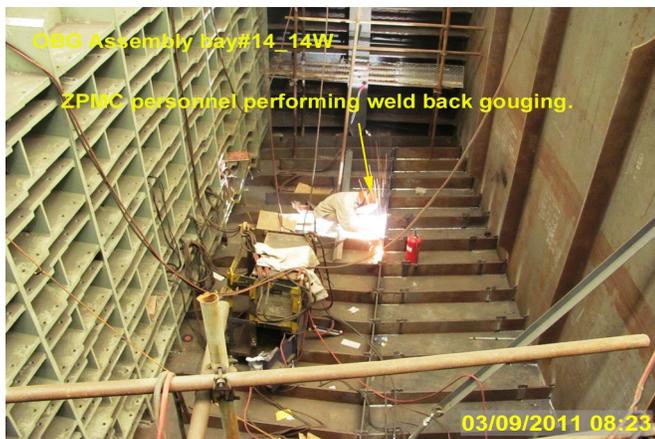
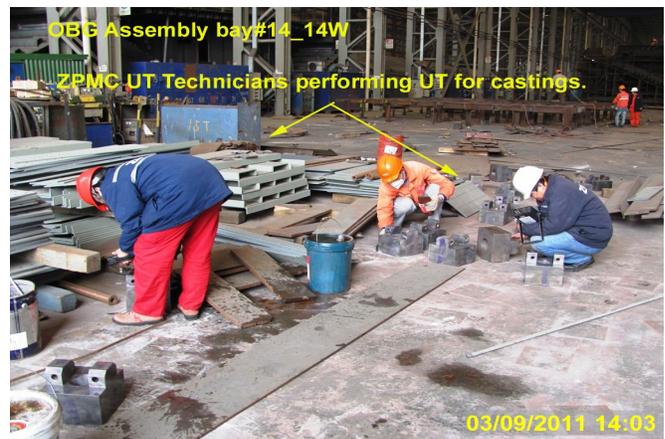
ZPMC UT Technician performing Ultrasonic Testing for the west line Anchor plate bearing blocks. Refer the attached photos for reference.
