DEPARTMENT OF TRANSPORTATION

Quality Assurance and Source Inspection

Contract #: 04-0120F4Cty: SF/Ala Rte: 80 PM: 13.2/13.9File #: 69.28**WELDING INSPECTION REPORT****Resident Engineer:** Siegenthaler, Peter**Address:** 333 Burma Road**City:** Oakland, CA 94607**Report No:** WIR-021712**Date Inspected:** 07-Mar-2011**Project Name:** SAS Superstructure**OSM Arrival Time:** 1900**Prime Contractor:** American Bridge/Fluor Enterprises, a JV**OSM Departure Time:** 700**Contractor:** Zhenhua Port Machinery Company, Ltd (ZPMC), Changxing Island **Location:** Shanghai, China**CWI Name:** See below**CWI Present:** Yes No**Inspected CWI report:** Yes No N/A**Rod Oven in Use:** Yes No N/A**Electrode to specification:** Yes No N/A**Weld Procedures Followed:** Yes No N/A**Qualified Welders:** Yes No N/A**Verified Joint Fit-up:** Yes No N/A**Approved Drawings:** Yes No N/A**Approved WPS:** Yes No N/A**Delayed / Cancelled:** Yes No N/A**Bridge No:** 34-0006**Component:** OBG Components**Summary of Items Observed:**

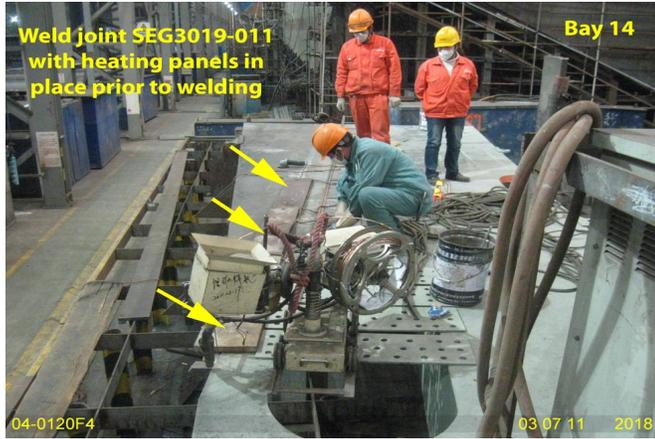
SAW welding of weld joint SEG3019-011 located on PCMK OBG 14E. Welder was identified as 058100. QC was identified as ZPMC QC Cui Zheng Hua (QC1), who was not a CWI. Weld variables recorded by QC1 appeared to comply with WPS-B-T-2221-B-L2c-S as verbally identified by QC1. See photo below of ZPMC worker adjusting electric heating panels prior to welding.

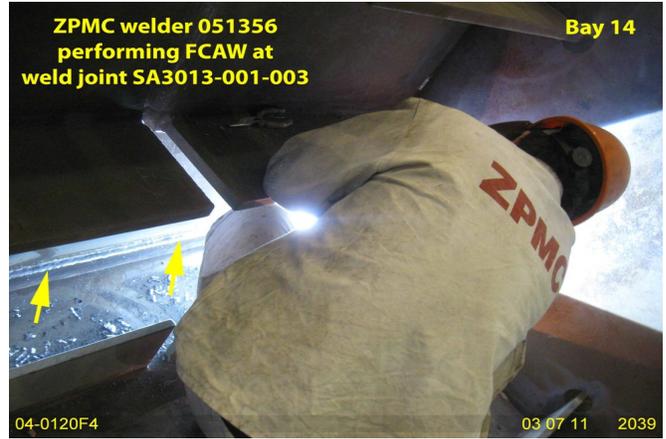
FCAW welding of weld joints SA3013-001-003 located on PCMK OBG 13BE. Welder was identified as 051356. QC was identified as QC1, who was not a CWI. Weld variables recorded by QC1 appeared to comply with WPS-B-T-2232-ESAB as verbally identified by QC1. See photo below of weld joint SA3013-001-003 being welded.
