DEPARTMENT OF TRANSPORTATION

Quality Assurance and Source Inspection

Contract #: 04-0120F4Cty: SF/ALA Rte: 80 PM: 13.2/13.9File #: 1.28**WELDING INSPECTION REPORT****Resident Engineer:** Siegenthaler, Peter**Address:** 333 Burma Road**City:** Oakland, CA 94607**Report No:** WIR-021719**Date Inspected:** 09-Mar-2011**Project Name:** SAS Superstructure**OSM Arrival Time:** 700**Prime Contractor:** American Bridge/Fluor Enterprises, a JV**OSM Departure Time:** 1730**Contractor:** American Bridge/Fluor Enterprises, a JV**Location:** Job Site

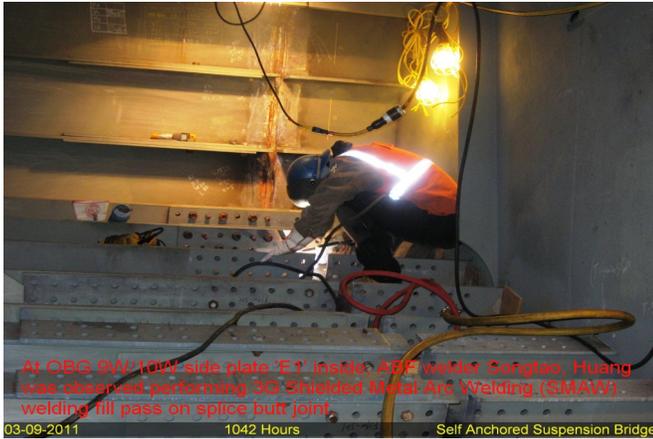
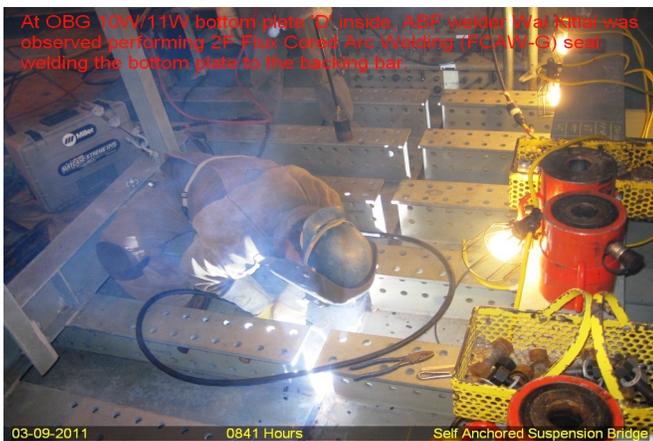
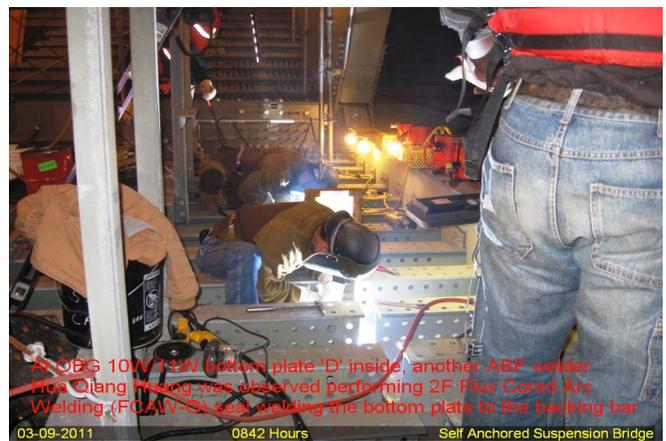
At OBG 9W/10W side plate 'E1' (0mm to 1000mm) and 'E2' (4580mm to 5278mm) inside, QA randomly observed ABF/JV qualified welder Sungtao, Huang ID # 3794 continuing to perform CJP groove (splice) welding fill pass to cover pass on the splice butt. The welder was observed perform manually welding in the 3G (vertical) position utilizing a Shielded Metal Arc Welding (SMAW) with 1/8" diameter E7018H4R electrode and implementing Caltrans approved Welding Procedure Specification (WPS) ABF-WPS-D15-1040B. The joint being welded has a single V-groove butt joint with backing bar. The splice joint was preheated with propane gas torch prior welding. During welding, ABF Quality Control (QC) Steve Jensen was noted monitoring the welding parameters of the welder. During the shift, cover pass welding was completed on both locations and the welder has moved to 'E1' (2640mm to 5278mm) of the same OBG and set up the Bug-o track mounted nozzle holder and FCAW-G welded the root pass.

At OBG 10E/11E edge plate 'B' outside/inside, QA randomly observed ABF/JV qualified welder Fred Kaddu continuing to perform cover pass welding on the Complete Joint Penetration (CJP) splice butt joint. The welder was observed manually welding in the 3G (vertical) position utilizing a Shielded Metal Arc Welding (SMAW) with 1/8" diameter E7018H4R electrode and implementing Caltrans approved Welding Procedure Specification (WPS) ABF-WPS-D15-1040B. The joint being welded has a single V-groove butt joint with steel backing bar. ABF Quality Control (QC) William Sherwood was noted monitoring the welding parameters of the welder. QA

At OBG 10W/11W bottom plate 'D' inside, QA randomly observed ABF/JV qualified welders Wai Kitlai and Hua Qiang Huang perform seal welding the bottom plates 'D1/D2' to the backing bar. The welders were utilizing a dual shield Flux Cored Arc Welding (FCAW-G) with E71T-1M, 1/16" diameter wire electrode and implementing Caltrans approved Welding Procedure Specification (WPS) ABF-WPS-D15-3040A-1. The joint has a single V-groove butt joint design with the bottom plate being seal welded with backing bar. The plate with the backing bar was preheated to greater than 150 degrees Fahrenheit using propane gas torch prior welding. During the shift, ABF QC William Sherwood was noted monitoring the welder. The welders have completed seal welding on both sides of the plates and then hand welded using the same process the two ends (north side, 600mm and south side, 800mm) of the splice wherein the SAW track mounted feeder has a limited access.

At OBG 10E/11E edge plate 'F' outside, QA randomly observed ABF/JV qualified welder Jin Pei Wang perform 3G CJP groove (splice) welding fill pass on the splice butt joint. The welder was observed manually welding in the 3G (vertical) position utilizing a Shielded Metal Arc Welding (SMAW) with 1/8" diameter E7018H4R electrode and implementing Caltrans approved Welding Procedure Specification (WPS) ABF-WPS-D15-1040B. The joint being welded has a single V-groove butt joint with steel backing bar. ABF Quality Control (QC) John Pagliero was noted monitoring the welding parameters of the welder. QA randomly monitored the welding parameter with reading of 138 amperes which appears in conformance to the contract requirements. During the shift while the welder was still welding fill pass on the butt joint, the welder was pulled out from this location and went to assist welding foreman James Zhen in tack welding/ fit up of the 10W/11W top deck plate 'A'.
