**DEPARTMENT OF TRANSPORTATION**

Contract #: 04-0120F4Cty: SF/ALA Rte: 80 PM: 13.2/13.9File #: 1.28**WELDING INSPECTION REPORT****Resident Engineer:** Siegenthaler, Peter**Address:** 333 Burma Road**City:** Oakland, CA 94607**Report No:** WIR-021731**Date Inspected:** 11-Mar-2011**Project Name:** SAS Superstructure**OSM Arrival Time:** 700**Prime Contractor:** American Bridge/Fluor Enterprises, a JV**OSM Departure Time:** 1730**Contractor:** American Bridge/Fluor Enterprises, a JV**Location:** Job Site

| <b>Bridge No:</b> | 34-0006 | <b>Component:</b> | Orthotropic Box Girder | |

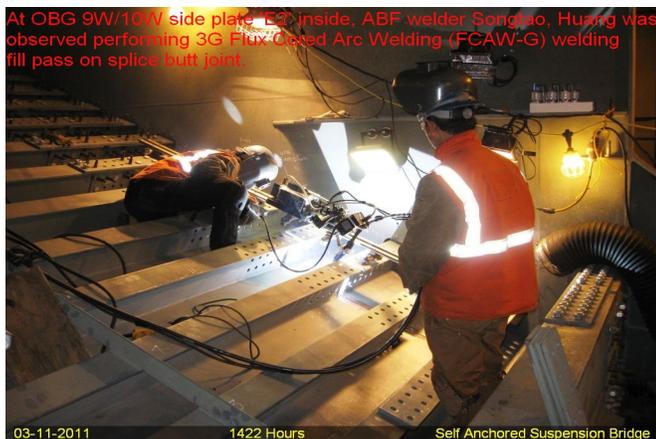
At OBG 9W/10W side plate 'E2' (2640mm to 4480mm) inside, QA randomly observed ABF/JV qualified welder Sungtao, Huang ID # 3794 continuing to perform CJP groove (splice) welding fill pass on the splice butt joint. The welder was observed perform automatic welding in the 3G (vertical) position utilizing a dual shield Flux Cored Arc Welding (FCAW-G) with E71T-1M, 1/16" diameter wire electrode and implementing Caltrans approved Welding Procedure Specification (WPS) ABF-WPS-D15-3042B-1. The joint being welded has a single V-groove butt joint with backing bar. The splice joint was preheated and maintained to greater than 150 degrees Fahrenheit using Miller Proheat 35 Induction Heating System heater blankets located at the opposite side of the plate prior/during welding. During welding, ABF Quality Control (QC) Steve Jensen was noted monitoring the welding parameters of the welder. At the end of the shift, fill pass welding was completed and the welder was ready to weld the cover pass Monday.

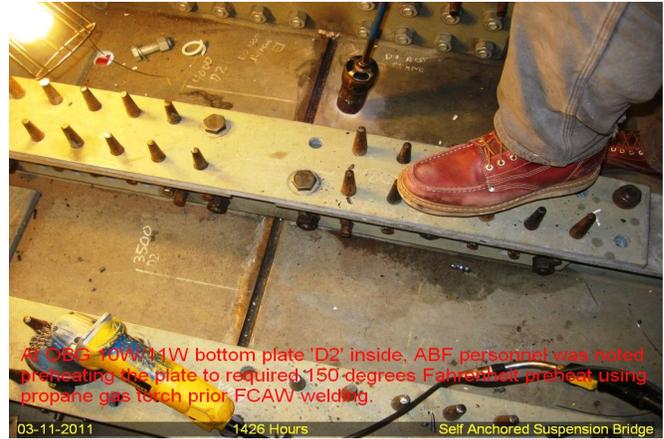
At OBG 10W/11W bottom plate 'D2' (3250mm to 4250mm) inside, QA randomly observed ABF/JV qualified welder Hua Qiang Hwang continuing to perform CJP groove (splice) welding fill pass on the splice butt joint. The welder was observed performing manual welding in the 1G (flat) position utilizing a dual shield Flux Cored Arc Welding (FCAW-G) with E71T-1M, 1/16" diameter wire electrode and implementing Caltrans approved Welding Procedure Specification (WPS) ABF-WPS-D15-3040A-1. The joint being welded has a single V-groove butt joint with backing bar and was welded using Submerged Arc Welding (SAW) on most part of the joint. But due to limited access of the SAW track mounted wire feeder to the corner location, welding was not completed. The splice joint was preheated to greater than 150 degrees Fahrenheit using propane gas torch prior welding. ABF Quality Control (QC) William Sherwood was noted monitoring the welding parameters of the welder. At the end of the shift, fill pass welding of the splice joint at location mentioned above was not completed and should continue Monday.
