DEPARTMENT OF TRANSPORTATION

Quality Assurance and Source Inspection

Contract #: 04-0120F4Cty: SF/ALA Rte: 80 PM: 13.2/13.9File #: 82.28**WELDING INSPECTION REPORT****Resident Engineer:** Siegenthaler, Peter**Address:** 333 Burma Road**City:** Oakland, CA 94607**Report No:** WIR-021742**Date Inspected:** 28-Feb-2011**Project Name:** SAS Superstructure**OSM Arrival Time:** 700**Prime Contractor:** American Bridge/Fluor Enterprises, a JV**OSM Departure Time:** 1530**Contractor:** Westmont Industries**Location:** Santa Fe Springs, CA.**CWI Name:** Ruben Dominguez**CWI Present:** Yes No**Inspected CWI report:** Yes No N/A**Rod Oven in Use:** Yes No N/A**Electrode to specification:** Yes No N/A**Weld Procedures Followed:** Yes No N/A**Qualified Welders:** Yes No N/A**Verified Joint Fit-up:** Yes No N/A**Approved Drawings:** Yes No N/A**Approved WPS:** Yes No N/A**Delayed / Cancelled:** Yes No N/A**Bridge No:** 34-0006**Component:** Travelers**Summary of Items Observed:**

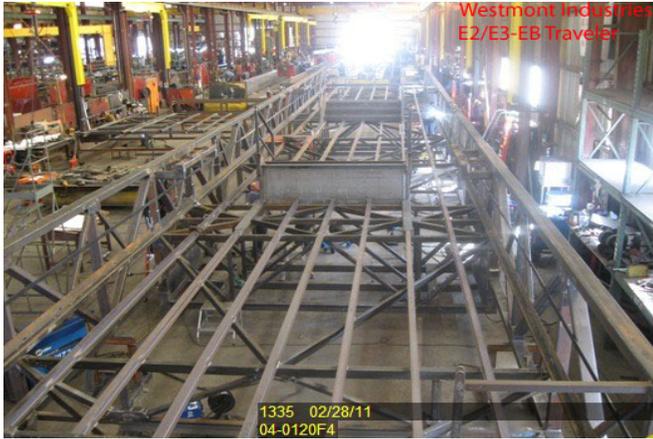
E2/E3-EB Traveler

This QA Inspector observed WMI production welder Mr. Juan Jimenez (WID # 3059) continuing to perform Flux Core Arc Welding (FCAW) activities on the E2/E3-EB Traveler assemblies. This QA Inspector observed Mr. Jimenez performing the FCAW in all positions on plate and tube steel material, randomly throughout the shift.

This QA Inspector observed WMI production welder Mr. Eutimo Lopez (WID # 3035) continuing to perform Flux Core Arc Welding (FCAW) activities on the E2/E3-EB Traveler assemblies. This QA Inspector observed Mr. Lopez performing the FCAW in all positions on plate and tube steel material, randomly throughout the shift.

This QA Inspector observed WMI personnel Mr. Cesar Canales continuing to perform dimensional layout and fitting activities and Mr. Jesus Rayas (WID # 3197) performing Flux Core Arc Welding (FCAW) tacking activities on the above mentioned assemblies.

See attached picture below.

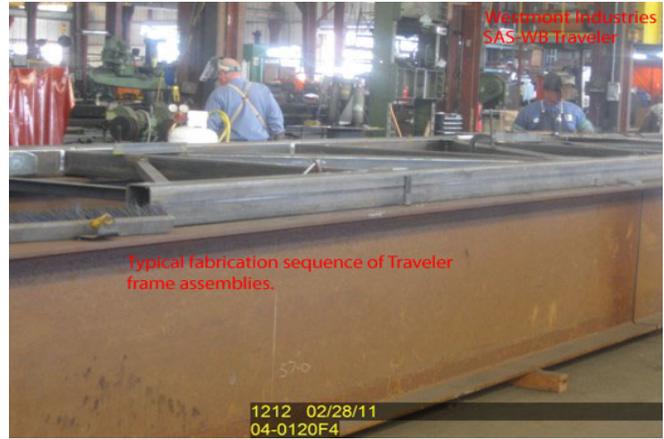
SAS-WB Traveler

This QA Inspector observed WMI production welder Mr. Jose Rodriguez (WID # 3031) continuing to perform Flux Core Arc Welding (FCAW) activities on the SAS-EB Traveler frame assemblies. This QA Inspector observed Mr. Rodriguez performing the FCAW in all positions on tube steel material, randomly throughout the shift.

See attached picture below.
