DEPARTMENT OF TRANSPORTATION

Quality Assurance and Source Inspection

Contract #: 04-0120F4Cty: SF/ALA Rte: 80 PM: 13.2/13.9File #: 69.28**WELDING INSPECTION REPORT****Resident Engineer:** Siegenthaler, Peter**Address:** 333 Burma Road**City:** Oakland, CA 94607**Report No:** WIR-021826**Date Inspected:** 17-Mar-2011**Project Name:** SAS Superstructure**OSM Arrival Time:** 700**Prime Contractor:** American Bridge/Fluor Enterprises, a JV**OSM Departure Time:** 1900**Contractor:** Zhenhua Port Machinery Company, Ltd (ZPMC), Changxing Island **Location:** Shanghai, China**CWI Name:** Zho Zhong Hai**CWI Present:** Yes No**Inspected CWI report:** Yes No N/A**Rod Oven in Use:** Yes No N/A**Electrode to specification:** Yes No N/A**Weld Procedures Followed:** Yes No N/A**Qualified Welders:** Yes No N/A**Verified Joint Fit-up:** Yes No N/A**Approved Drawings:** Yes No N/A**Approved WPS:** Yes No N/A**Delayed / Cancelled:** Yes No N/A**Bridge No:** 34-0006**Component:** Orthotropic Box Girder (OBG)**Summary of Items Observed:**

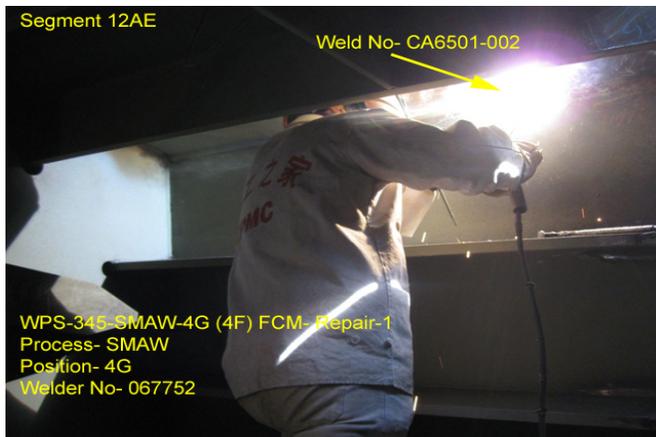
This QA Inspector observed ZPMC qualified welding personnel identified as 067752 perform Shielded Metal Arc Welding (SMAW), weld joint identified as CA6501-002; located On Orthotropic Box Girder (OBG) Deck Plate to Edge Plate CJP Weld; ZPMC Quality Control (QC) is identified as Mr. Wang Li Yang. This QA Inspector observed the base material appears to have been preheated by an electrical heating element prior to welding The Critical Welding Repair Report (CWRR) was B-CWR2860. ZPMC Quality Control (QC) Mr. Wang Li Yang was onsite monitoring the welding variables. The welding variables recorded by QC appeared to comply with applicable WPS-345-SMAW-4G (4F) FCM-Repair-1. See attached photo for further details.

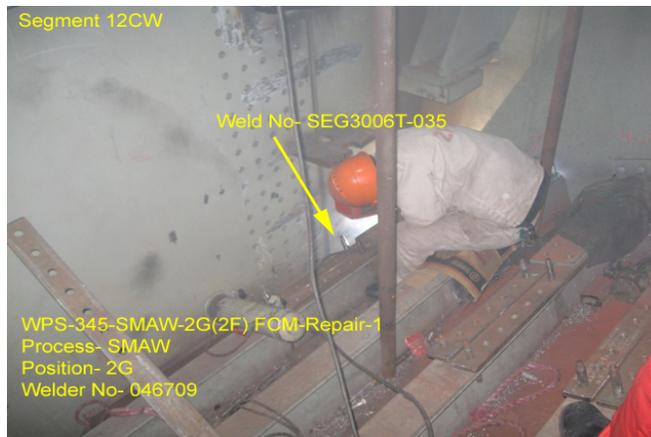
This QA Inspector observed ZPMC qualified welding personnel identified as 046709 perform Shielded Metal Arc Welding (SMAW), weld joint identified as SEG3006T-035; located On Orthotropic Box Girder (OBG) Deck Plate to Edge Plate CJP Weld; ZPMC Quality Control (QC) is identified as Mr. Wang Li Yang. This QA Inspector observed the base material appears to have been preheated by an electrical heating element prior to welding The Welding Repair Report (WRR) was B-WR2860. ZPMC Quality Control (QC) Mr. Wang Li Yang was onsite monitoring the welding variables. The welding variables recorded by QC appeared to comply with applicable WPS-345-SMAW-2G (2F) FCM-Repair-1. See attached photo for further details.
