Contract #: 04-0120F4Cty: SF/ALA Rte: 80 PM: 13.2/13.9File #: 69.28**WELDING INSPECTION REPORT****Resident Engineer:** Siegenthaler, Peter**Address:** 333 Burma Road**City:** Oakland, CA 94607**Report No:** WIR-021895**Date Inspected:** 11-Mar-2011**Project Name:** SAS Superstructure**OSM Arrival Time:** 1500**Prime Contractor:** American Bridge/Fluor Enterprises, a JV**OSM Departure Time:** 300**Contractor:** Zhenhua Port Machinery Company, Ltd (ZPMC), Changxing Island **Location:** Shanghai, China**CWI Name:** Mr. Xu Tao**CWI Present:** Yes No**Inspected CWI report:** Yes No N/A**Rod Oven in Use:** Yes No N/A**Electrode to specification:** Yes No N/A**Weld Procedures Followed:** Yes No N/A**Qualified Welders:** Yes No N/A**Verified Joint Fit-up:** Yes No N/A**Approved Drawings:** Yes No N/A**Approved WPS:** Yes No N/A**Delayed / Cancelled:** Yes No N/A**Bridge No:** 34-0006**Component:** OBG**Summary of Items Observed:**

WELDING INSPECTION REPORT

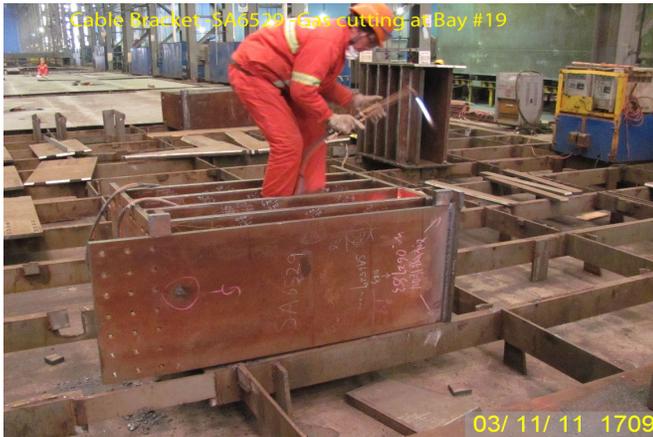
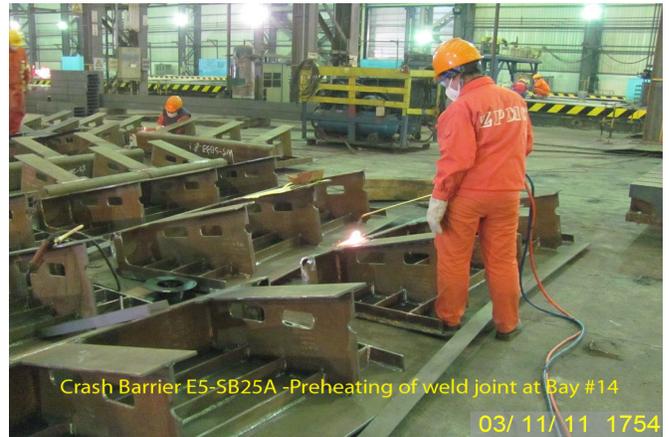
For further information see below pictures:-

Unless otherwise noted, all work observed on this date appeared to be in general compliance with the applicable contract documents.
