DEPARTMENT OF TRANSPORTATION

Contract #: 04-0120F4Cty: SF/Ala Rte: 80 PM: 13.2/13.9File #: 69.28**WELDING INSPECTION REPORT****Resident Engineer:** Siegenthaler, Peter**Address:** 333 Burma Road**City:** Oakland, CA 94607**Report No:** WIR-021958**Date Inspected:** 21-Feb-2011**Project Name:** SAS Superstructure**OSM Arrival Time:** 1900**Prime Contractor:** American Bridge/Fluor Enterprises, a JV**OSM Departure Time:** 700**Contractor:** Zhenhua Port Machinery Company, Ltd (ZPMC), Changxing Island **Location:** Shanghai, China**CWI Name:** See below**CWI Present:** Yes No**Inspected CWI report:** Yes No N/A**Rod Oven in Use:** Yes No N/A**Electrode to specification:** Yes No N/A**Weld Procedures Followed:** Yes No N/A**Qualified Welders:** Yes No N/A**Verified Joint Fit-up:** Yes No N/A**Approved Drawings:** Yes No N/A**Approved WPS:** Yes No N/A**Delayed / Cancelled:** Yes No N/A**Bridge No:** 34-0006**Component:** OBG Components**Summary of Items Observed:**

WELDING INSPECTION REPORT

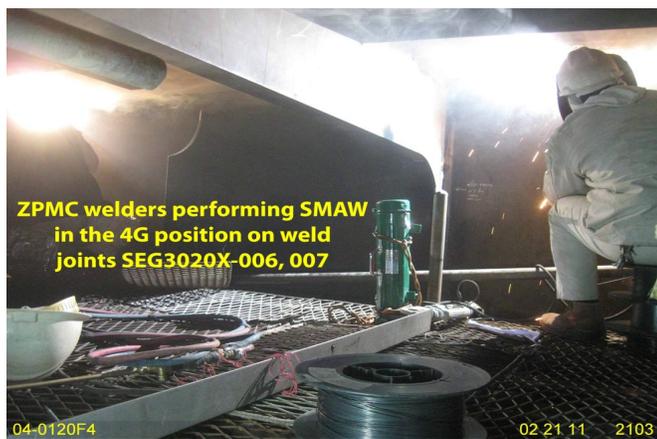
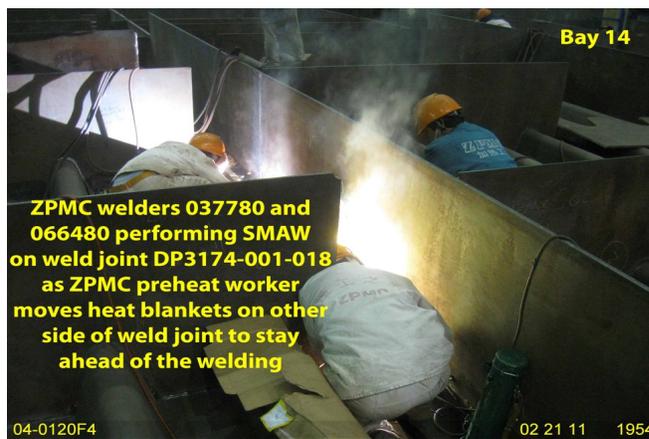
This QA Inspector randomly observed the following work in progress in the Bay 14:

SMAW welding of weld joint DP3174-001-018 located on PCMK OBG 14W. Welders were identified as 037780, 066480. QC was identified as ABF CWI Li Shi You (QC1). Assisting QC1 at this location and appearing to be monitoring the welding operation and recording data was ZPMC QC Li Ping (QCA1), who was not a CWI. Weld variables recorded by QCA1 appeared to comply with WPS-B-P-2212-TC-U4b-FCM-1 as verbally identified by QCA1.

SMAW tack welding of weld joint SEG3013-012 located on PCMK OBG 13AW. Welder was identified as 0048694. QC was identified as QC1. Assisting QC1 at this location and appearing to be monitoring the welding operation and recording data was QCA1, who was not a CWI. Weld variables recorded by QCA1 appeared to comply with WPS-B-P-2111 as verbally identified by QCA1.

FCAW welding of weld joint SEG3013R-020 located on PCMK OBG 13AW. Welders were identified as 067826, 066421. QC was identified as QC1. Assisting QC1 at this location and appearing to be monitoring the welding operation and recording data was QCA1, who was not a CWI. Weld variables recorded by QCA1 appeared to comply with WPS-B-T-2232-ESAB as verbally identified by QCA1.

FCAW welding of weld joint SEG3020BB-115 located on PCMK OBG 14W. Welder was identified as 067949. QC was identified as QC1. Assisting QC1 at this location and appearing to be monitoring the welding operation and recording data was QCA1, who was not a CWI. Weld variables recorded by QCA1 appeared to comply with WPS-B-T-2233-ESAB as verbally identified by QCA1.

SMAW welding of weld joints SEG3020X-006, 007 located on PCMK OBG 14W. Welders were identified, respectively, as 067609, 067764. QC was identified as QC1. Assisting QC1 at this location and appearing to be monitoring the welding operation and recording data was QCA1, who was not a CWI. Weld variables recorded by QCA2 appeared to comply with WPS-B-P-2114-TC-U4b-FCM-1 as verbally identified by QCA1.

SMAW repair welding of weld joint SEG3020BB-055 located on PCMK OBG 14W. Welder was identified as 066038. QC was identified as QC1. Assisting QC1 at this location and appearing to be monitoring the welding operation and recording data was QCA1, who was not a CWI. Weld variables recorded by QCA1 appeared to comply with WPS-345-SMAW-2G(2F)-FCM-repair-1 as displayed on ZPMC Weld Repair Report B-CWR2752 presented to this QA Inspector and verbally identified by QCA1.

Unless otherwise noted, all work observed on this date appeared to generally comply with applicable contract documents.
