**DEPARTMENT OF TRANSPORTATION**

Contract #: 04-0120F4Cty: SF/Ala Rte: 80 PM: 13.2/13.9File #: 69.28**WELDING INSPECTION REPORT****Resident Engineer:** Siegenthaler, Peter**Address:** 333 Burma Road**City:** Oakland, CA 94607**Report No:** WIR-021961**Date Inspected:** 25-Feb-2011**Project Name:** SAS Superstructure**OSM Arrival Time:** 1900**Prime Contractor:** American Bridge/Fluor Enterprises, a JV**OSM Departure Time:** 700**Contractor:** Zhenhua Port Machinery Company, Ltd (ZPMC), Changxing Island **Location:** Shanghai, China**CWI Name:** See below**CWI Present:** Yes No**Inspected CWI report:** Yes No N/A**Rod Oven in Use:** Yes No N/A**Electrode to specification:** Yes No N/A**Weld Procedures Followed:** Yes No N/A**Qualified Welders:** Yes No N/A**Verified Joint Fit-up:** Yes No N/A**Approved Drawings:** Yes No N/A**Approved WPS:** Yes No N/A**Delayed / Cancelled:** Yes No N/A**Bridge No:** 34-0006**Component:** OBG Components**Summary of Items Observed:**

## WELDING INSPECTION REPORT

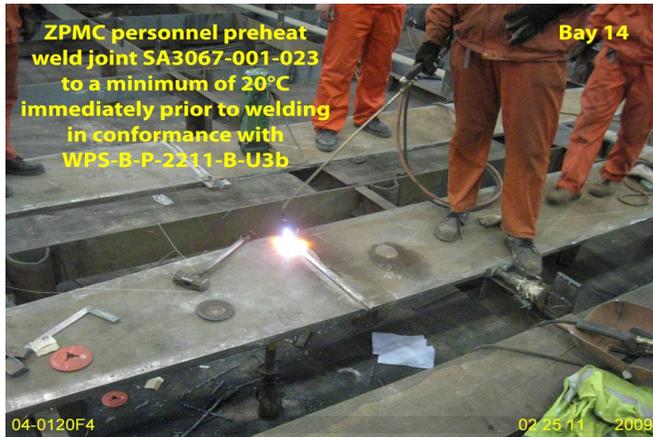
SMAW tack welding during fit-up and then SMAW welding of weld joint SA3067-001-023 located on PCMK OBG 14. Tack welder was identified as 047749 and welder was identified as 044779. QC was identified as ABF CWI Bao Qian (QC1). Weld variables recorded by QC1 appeared to comply with WPS-B-P-2211-B-U3b as verbally identified by QC1. See photo below of the weld joint being preheated immediately prior to welding.

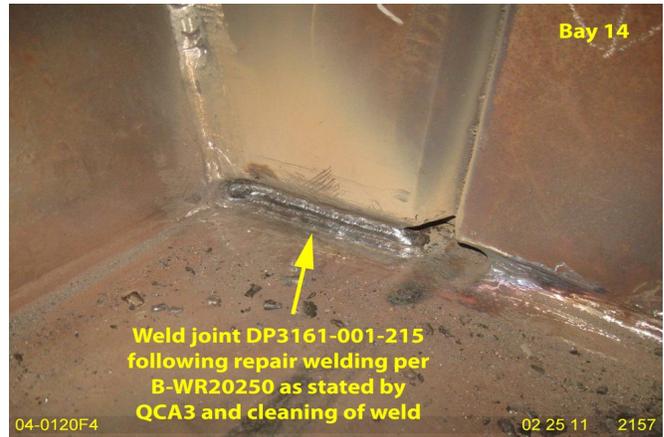
SMAW repair welding of weld joint DP3161-001-215 located on PCMK OBG 14E. Welder was identified as 037932. QC was identified as ABF CWI Bao Qian (QC3). Assisting QC3 at this location and appearing to be monitoring the welding operation and recording data was QCA3, who was not a CWI. Weld variables recorded by QCA3 appeared to comply with WPS-345-SMAW-2G(2F)-FCM-repair as displayed on ZPMC Weld Repair Report B-WR20250 presented to this QA Inspector and verbally identified by QCA3. See photo below of the repair as welded and cleaned.
