Contract #: 04-0120F4Cty: SF/ALA Rte: 80 PM: 13.2/13.9File #: 69.28**WELDING INSPECTION REPORT****Resident Engineer:** Siegenthaler, Peter**Address:** 333 Burma Road**City:** Oakland, CA 94607**Report No:** WIR-021998**Date Inspected:** 13-Mar-2011**Project Name:** SAS Superstructure**OSM Arrival Time:** 700**Prime Contractor:** American Bridge/Fluor Enterprises, a JV**OSM Departure Time:** 1900**Contractor:** Zhenhua Port Machinery Company, Ltd (ZPMC), Changxing Island **Location:** Shanghai, China**CWI Name:** Mr. An Qing Xian.**CWI Present:** Yes No**Inspected CWI report:** Yes No N/A**Rod Oven in Use:** Yes No N/A**Electrode to specification:** Yes No N/A**Weld Procedures Followed:** Yes No N/A**Qualified Welders:** Yes No N/A**Verified Joint Fit-up:** Yes No N/A**Approved Drawings:** Yes No N/A**Approved WPS:** Yes No N/A**Delayed / Cancelled:** Yes No N/A**Bridge No:** 34-0006**Component:** Orthotropic Box Girder (OBG)**Summary of Items Observed:**

OBG 14EAST

## WELDING INSPECTION REPORT

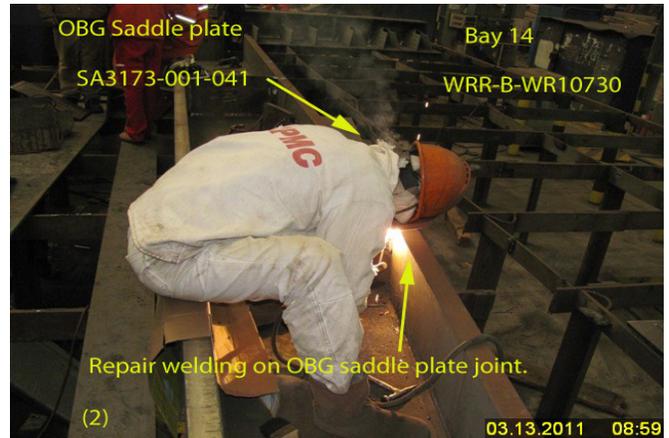
This QA Inspector observed ZPMC qualified welding personnel identified as 066398 Perform Shielded Metal Arc Welding (SMAW) on OBG Saddle plate. Joint identified as SA3173-001-041. ZPMC QC Identified as Li Ping with Temporary welding repair report WRR-B-WR10730. The welding parameters as measured using QC's calibrated instrument appeared to be in general compliance with WPS-345-SMAW-3G (3F) Repair. For more information see attached picture number 2.
