Contract #: 04-0120F4Cty: SF/ALA Rte: 80 PM: 13.2/13.9File #: 1.28**WELDING INSPECTION REPORT****Resident Engineer:** Siegenthaler, Peter**Address:** 333 Burma Road**City:** Oakland, CA 94607**Report No:** WIR-022206**Date Inspected:** 30-Mar-2011**Project Name:** SAS Superstructure**OSM Arrival Time:** 700**Prime Contractor:** American Bridge/Fluor Enterprises, a JV**OSM Departure Time:** 1530**Contractor:** American Bridge/Fluor Enterprises, a JV**Location:** Job Site

CWI Name:	Steve Jensen and Fred Von Hoff	CWI Present:	Yes	No	
Inspected CWI report:	Yes No N/A	Rod Oven in Use:	Yes	No	N/A
Electrode to specification:	Yes No N/A	Weld Procedures Followed:	Yes	No	N/A
Qualified Welders:	Yes No N/A	Verified Joint Fit-up:	Yes	No	N/A
Approved Drawings:	Yes No N/A	Approved WPS:	Yes	No	N/A
		Delayed / Cancelled:	Yes	No	N/A
Bridge No:	34-0006	Component:	Orthotropic Box Girder

WELDING INSPECTION REPORT

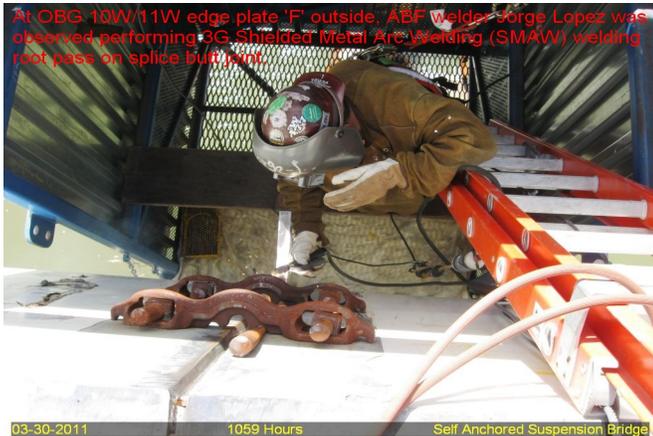
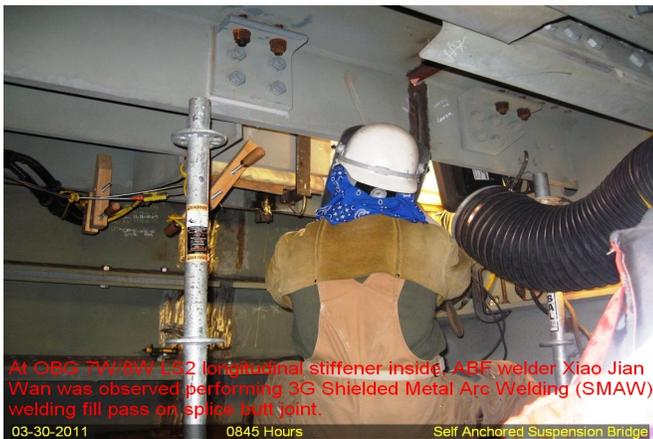
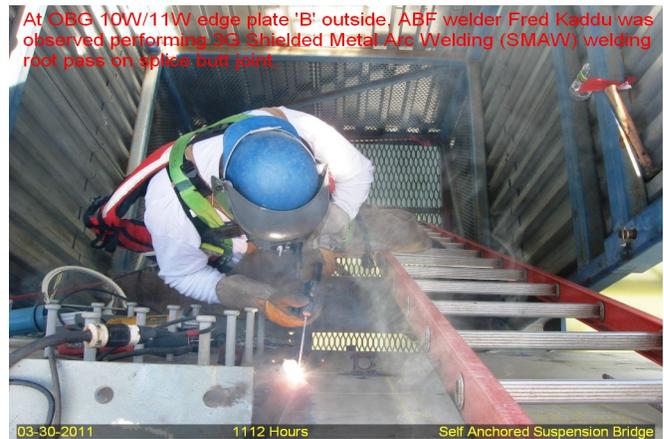
At OBG 9W/10W side plate 'C1' (2640mm to 5278mm) inside, QA randomly observed ABF/JV qualified welder Sungtao, Huang ID # 3794 continuing to perform CJP groove (splice) welding fill pass to cover pass on the splice butt joint. The welder was observed perform automatic welding in the 3G (vertical) position utilizing a dual shield Flux Cored Arc Welding (FCAW-G) with E71T-1M, 1/16" diameter wire electrode and implementing Caltrans approved Welding Procedure Specification (WPS) ABF-WPS-D15-3042B-1. The joint being welded has a single V-groove butt joint with backing bar. The splice joint was preheated and maintained to greater than 150 degrees Fahrenheit using Miller Proheat 35 Induction Heating System heater blankets located at the opposite side of the plate prior/during welding. During welding, ABF Quality Control (QC) Steve Jensen was noted monitoring the welding parameters of the welder. During the shift, cover pass welding was completed and the welder has moved to side plate 'C2' (2640mm to 5277mm) of the same OBG. The welder was noted cleaning the joint's bevel faces in preparation for the root pass tomorrow.

At OBG 10E/11E LS6 longitudinal stiffener inside, QA randomly observed ABF welder Hua Qiang Hwang continuing to perform 3G (vertical) Shielded Metal Arc Welding (SMAW) complete joint penetration (CJP) welding fill pass to cover pass on the stiffener splice butt joint. The stiffener plates being welded are made of high strength plate material HPS 485W and has a thickness of 30mm. The joint has a double V joint preparation that was welded from one side and after the completion from one side to be back gouged, Non Destructive Testing

At OBG 7W/8W LS2 longitudinal stiffener inside, QA randomly observed ABF welder Xiao Jian Wan perform 3G (vertical) SMAW back welding fill pass on the stiffener CJP splice butt joint. The joint has a double V joint preparation that was welded from one side using E9018H4R with 1/8" diameter electrode implementing Caltrans approved welding procedure specification (WPS) ABF-WPS-D1.5-1012-3. The joint being welded was root welded using a ceramic backing, fully welded from one side then back gouged and was ground smooth. The other side was back gouged and ground smooth and was also Non Destructive Testing (NDT) tested using the MT. The splice joint was preheated to greater than 200 degrees Fahrenheit using Miller Proheat 35 Induction Heating System located at the opposite side of the plate prior/during welding. QA noted the ABF QC Gary Ersham was on site monitoring the in process preheats and welding parameters. During the shift, QA noted ABF QC Gary Ersham was closely monitoring the issuance of E9018H4R electrodes due to its limited exposure time allowed. At the end of the shift, cover pass welding on both sides of the stiffener was completed. The welder was also instructed by QC to keep the preheat maintenance of more than 200 degrees Fahrenheit after welding and hold it for three hours as required.

At OBG 8W/9W LS5 longitudinal stiffener inside, QA randomly observed ABF welder Jin Pei Wang perform 3G (vertical) Shielded Metal Arc Welding (SMAW) complete joint penetration (CJP) welding fill pass on the stiffener splice butt joint. The stiffener plates being welded are made of high strength plate material HPS 485W and has a thickness of 30mm. The joint has a double V joint preparation that was welded from one side and after the completion from one side to be back gouged, Non Destructive Testing (NDT) tested using Magnetic Particle Testing (MT) and back welded to the other side. The welder was noted using E9018H4R with 1/8" diameter electrode implementing Caltrans approved welding procedure specification (WPS) ABF-WPS-D1.5-1012-3. The joint being welded was root welded using a ceramic backing. The splice joint was preheated to greater than 200 degrees Fahrenheit using Miller Proheat 35 Induction Heating System heater blanket located at the opposite side of the plate prior/during welding. The QA Inspector noted the ABF QC Gary Ersham was on site monitoring the in process preheats and welding parameters. During the shift, QA noted ABF QC Gary Ersham was closely monitoring the issuance of E9018H4R electrodes due to its limited exposure time allowed. At the end of the shift, fill pass welding on one side of the butt joint was still ongoing and should continue tomorrow.

At OBG 10W/11W edge plate 'B' and 'F' outside, QA randomly observed ABF/JV qualified welders Fred Kaddu and Jorge Lopez respectively perform root pass welding on the Complete Joint Penetration (CJP) splice butt joints. The welders were observed manually welding in the 3G (vertical) position utilizing a Shielded Metal Arc Welding (SMAW) with 1/8" diameter E7018H4R electrode and implementing Caltrans approved Welding Procedure Specification (WPS) ABF-WPS-D15-1040B. The joints being welded have a single V-groove butt joint with steel

At OBG 9E/10E side plate 'E' outside, ABF welder Rory Hogan was noted setting up plasma arc gouging machine and covering the location with tarp in preparation for the back gouging/backing bar removal of the welded splice butt joint.
