DEPARTMENT OF TRANSPORTATION

Office of Structural Materials

Contract #: 04-0120F4Cty: SF/ALA Rte: 80 PM: 13.2/13.9File #: 69.28**WELDING INSPECTION REPORT****Resident Engineer:** Siegenthaler, Peter**Address:** 333 Burma Road**City:** Oakland, CA 94607**Report No:** WIR-022262**Date Inspected:** 31-Mar-2011**Project Name:** SAS Superstructure**OSM Arrival Time:** 700**Prime Contractor:** American Bridge/Fluor Enterprises, a JV**OSM Departure Time:** 1900**Contractor:** Zhenhua Port Machinery Company, Ltd (ZPMC), Changxing Island **Location:** Shanghai, China**CWI Name:** Liu Hua Jie.**CWI Present:** Yes No**Inspected CWI report:** Yes No N/A**Rod Oven in Use:** Yes No N/A**Electrode to specification:** Yes No N/A**Weld Procedures Followed:** Yes No N/A**Qualified Welders:** Yes No N/A**Verified Joint Fit-up:** Yes No N/A**Approved Drawings:** Yes No N/A**Approved WPS:** Yes No N/A**Delayed / Cancelled:** Yes No N/A**Bridge No:** 34-0006**Component:** OBG components.**Summary of Items Observed:**

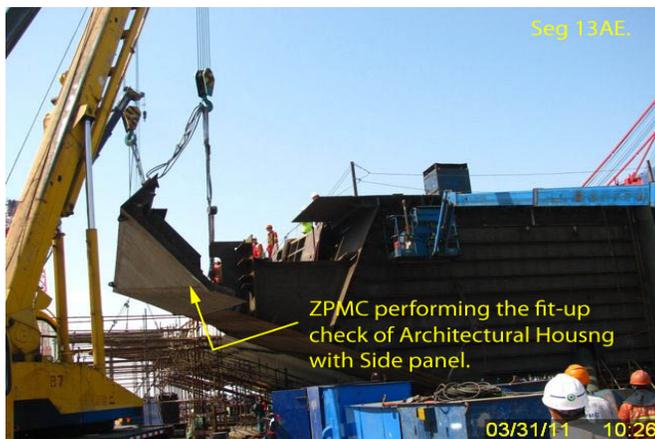
This QA Inspector observed ZPMC personnel performing fit-up checking of Architectural Housing with Side Panel of the Segment. See attached photo for details.
