Contract #: 04-0120F4Cty: SF/ALA Rte: 80 PM: 13.2/13.9File #: 69.28**WELDING INSPECTION REPORT****Resident Engineer:** Siegenthaler, Peter**Address:** 333 Burma Road**City:** Oakland, CA 94607**Report No:** WIR-022265**Date Inspected:** 01-Apr-2011**Project Name:** SAS Superstructure**OSM Arrival Time:** 700**Prime Contractor:** American Bridge/Fluor Enterprises, a JV**OSM Departure Time:** 1900**Contractor:** Zhenhua Port Machinery Company, Ltd (ZPMC), Changxing Island **Location:** Shanghai, China**CWI Name:** Mr. Shi zhi**CWI Present:** Yes No**Inspected CWI report:** Yes No N/A**Rod Oven in Use:** Yes No N/A**Electrode to specification:** Yes No N/A**Weld Procedures Followed:** Yes No N/A**Qualified Welders:** Yes No N/A**Verified Joint Fit-up:** Yes No N/A**Approved Drawings:** Yes No N/A**Approved WPS:** Yes No N/A**Delayed / Cancelled:** Yes No N/A**Bridge No:** 34-0006**Component:** Orthotropic Box Girder (OBG)**Summary of Items Observed:**

OBG Trial Assembly open yard.

Segment: 13AW

WELDING INSPECTION REPORT

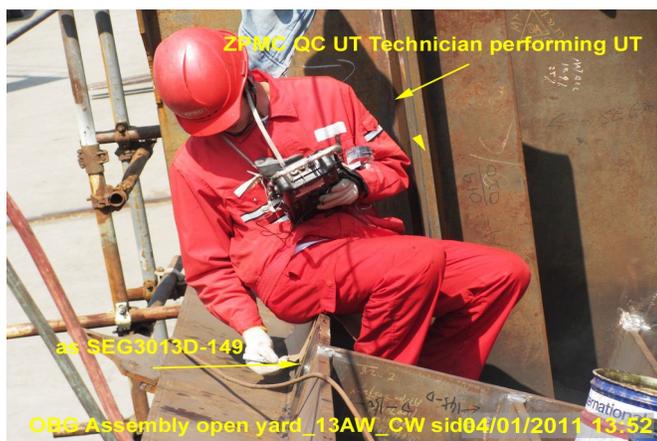
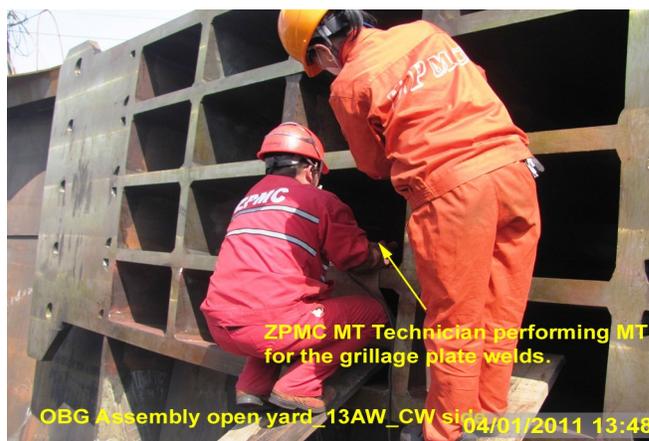
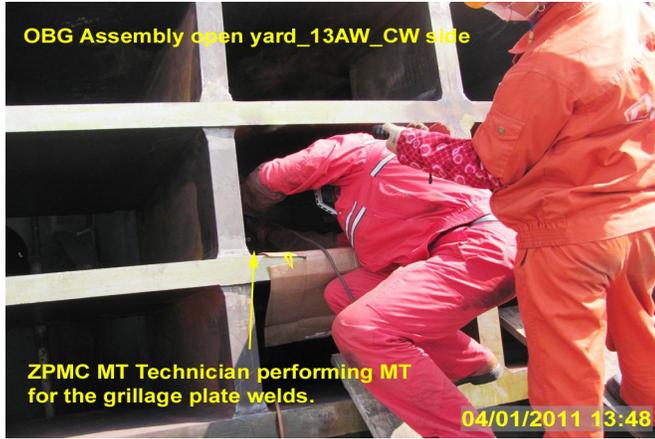
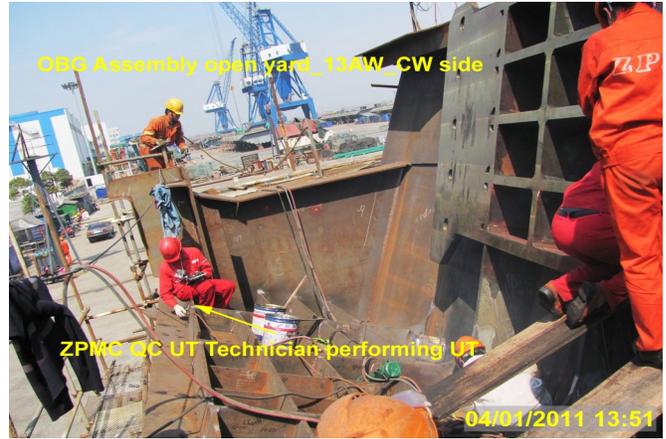
ZPMC QC UT Technician performing Ultrasonic Testing for the weld joint identified as SEG3013D-149 at Panel point 119 counter weight side. See attached photos for further information.

ZPMC MT Technician performing Magnetic Particle Testing for the grillage plate welds at Panel point 119 counter weight side. See attached photos for further information.
